Gearbox Borescope Inspection

Ventos Metodicos Warehouse

WTG 1

Author	Daniel Fuentes Moncayo
Date	06/11/2025
Ref.	VMW_001_2025-11-06_GBB

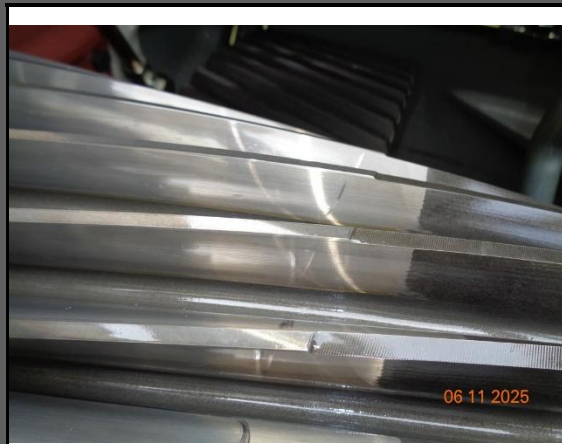
Position:	A - HSS pinion

Level:	W1-C0-H0

Obs: adhesion

There is presence of abrasion and adhesion signs in the teeth of the gear.

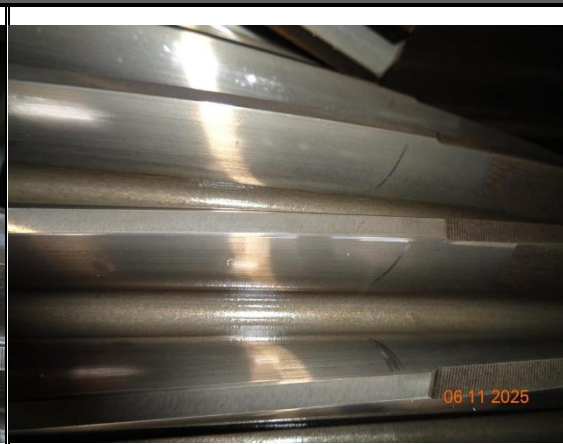
Obs: abrasion and adhesion

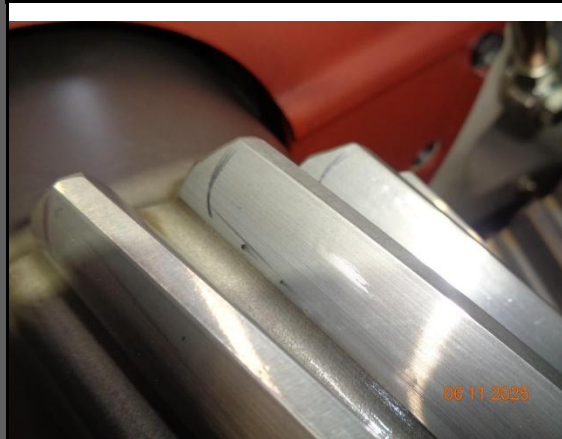
Obs: adhesion

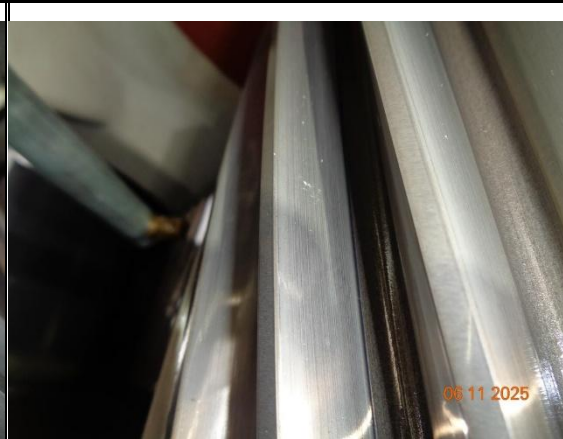
Obs: abrasion

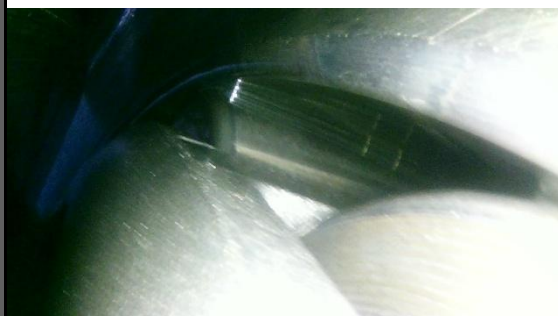
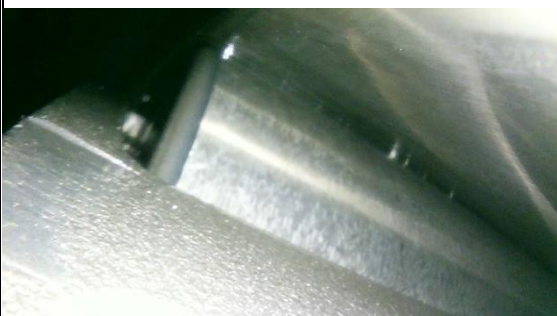
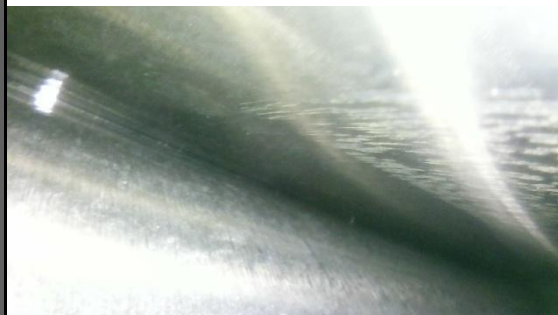
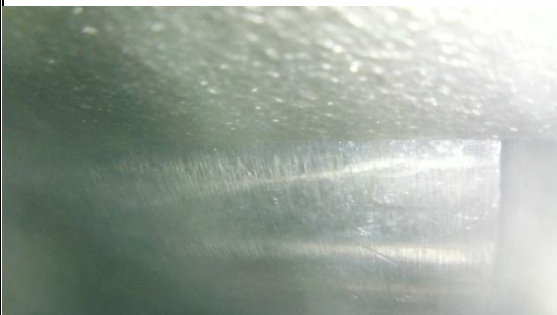
Position:	1 - HSS bearing GEN

Level:	W1-C0-H0

Obs: OK	Obs: OK

Obs: scoring	Obs: OK

There is presence of scoring signs in the surfaces of the bearing.

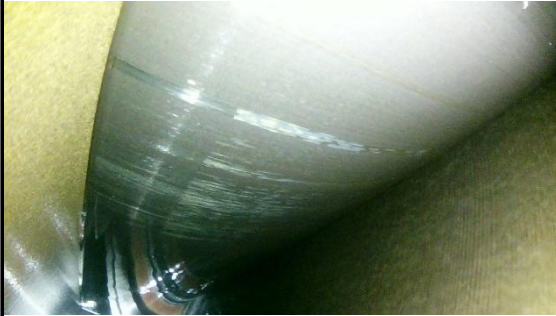
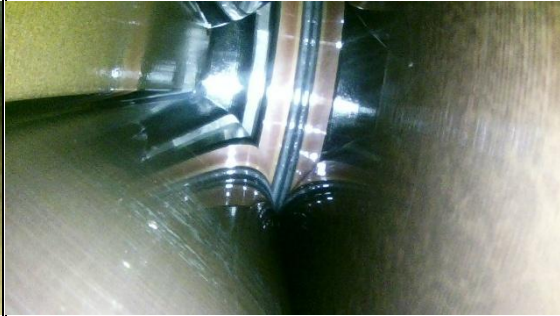
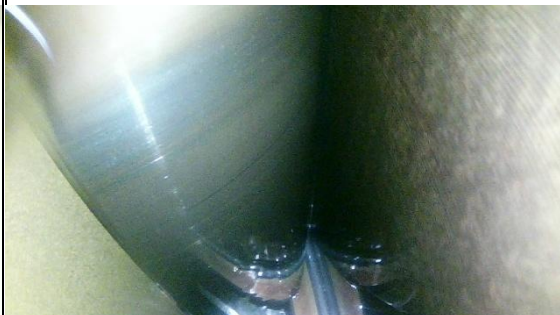
Position:	2 - HSS bearing ROT

Level:	W1-C0-H0

Obs: adhesion and scoring

Obs: adhesion

There is presence of adhesion and scoring signs in the surfaces of the bearing.

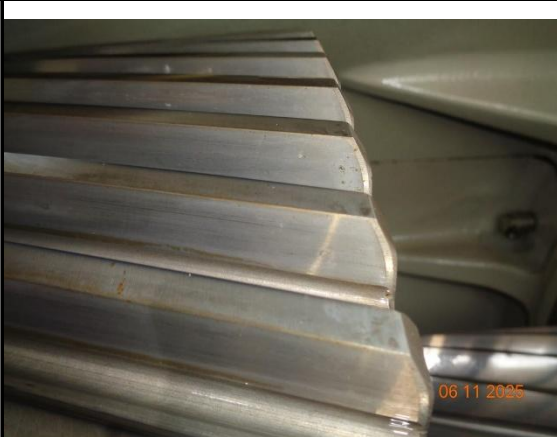
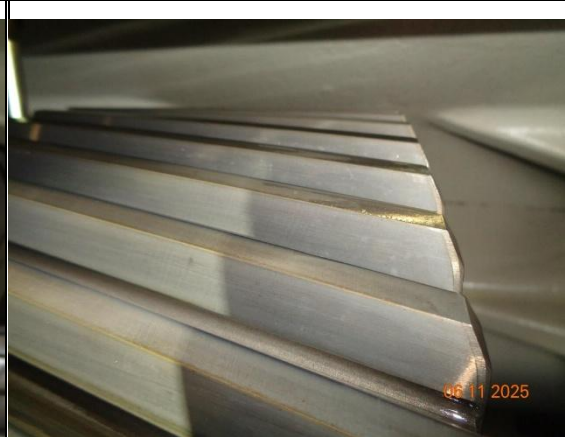
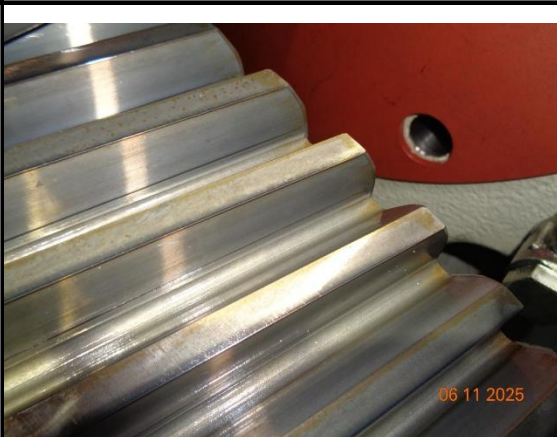
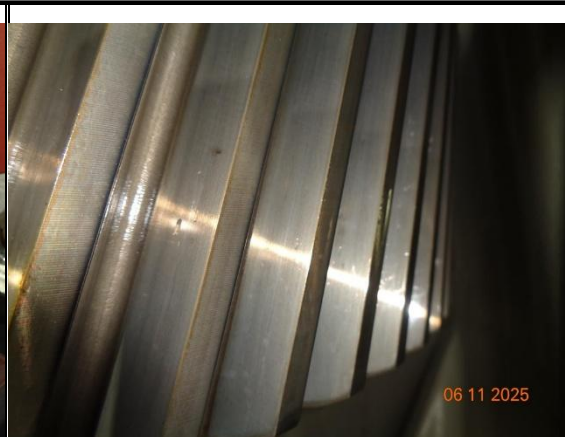
Position:	B - ISS wheel

Level:	W1-C0-H0

Obs: adhesion

There is presence of slight abrasion signs in the teeth of the gear.

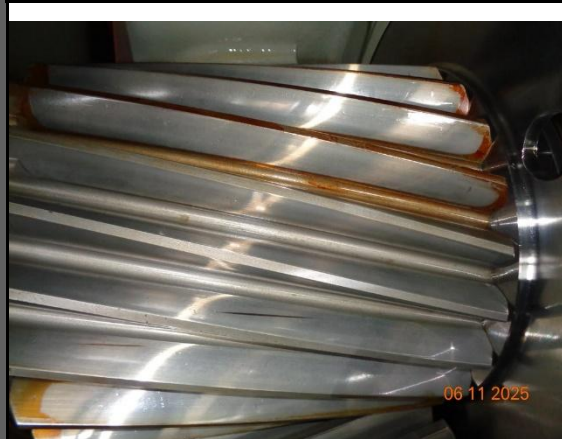
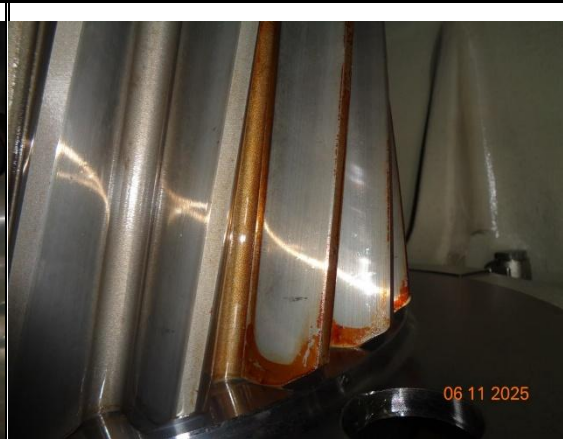
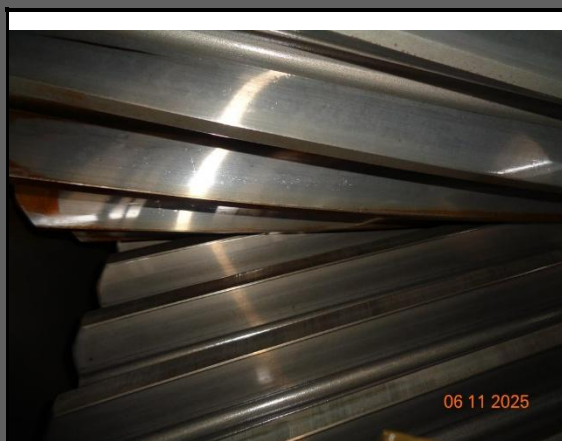
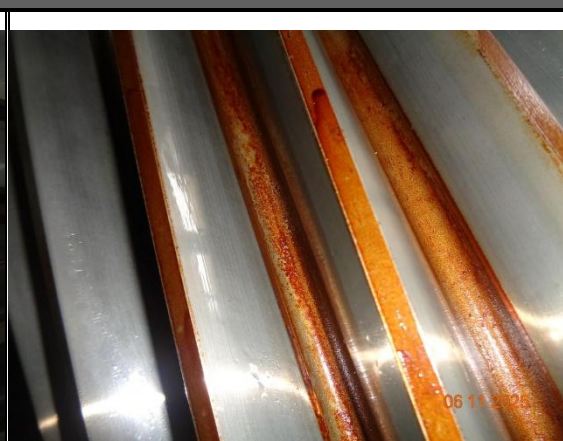
Position:	C - ISS pinion

Level:	W1-C0-H0

Obs: abrasion and standstill marks

Obs: abrasion

There is presence of abrasion signs and standstill marks in the teeth of the gear.

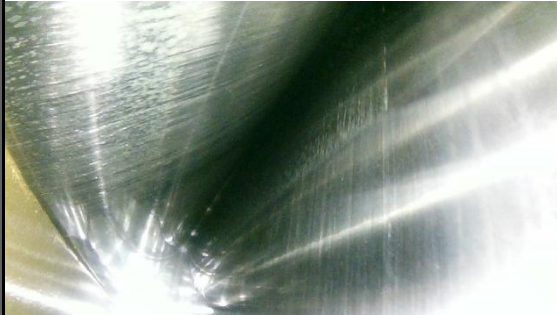
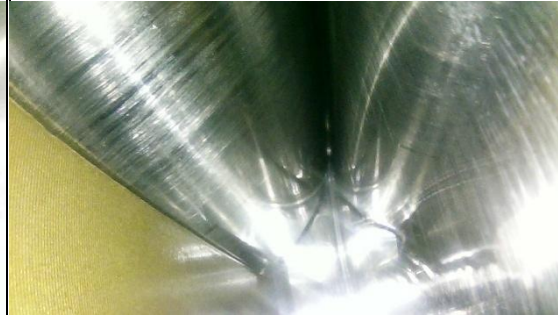
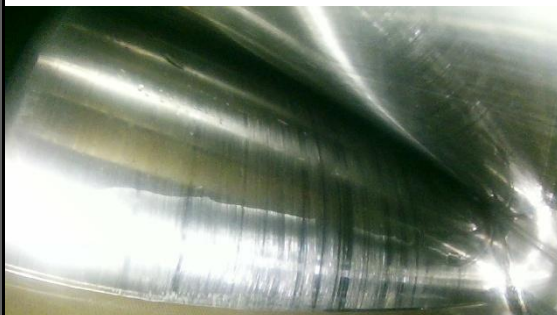
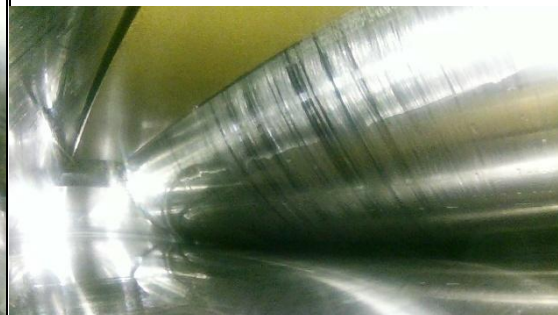
Position:	3 - IMS bearing GEN

Level:	W1-C0-H0

Obs: scoring	Obs: adhesion

Obs: adhesion	Obs: adhesion

There is presence of adhesion and scoring signs in the surfaces of the bearing.

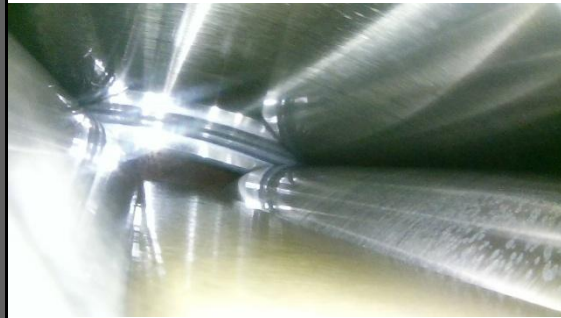
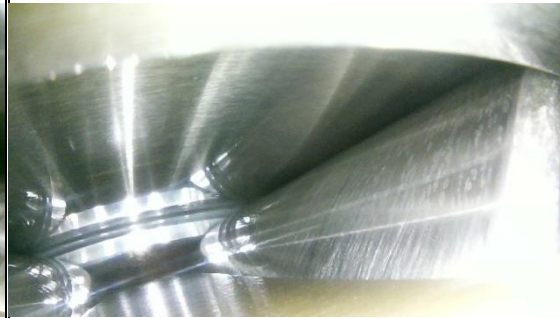
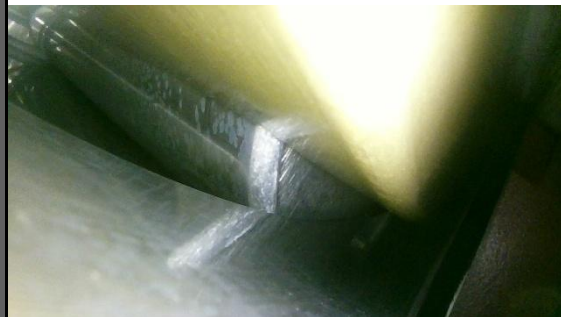
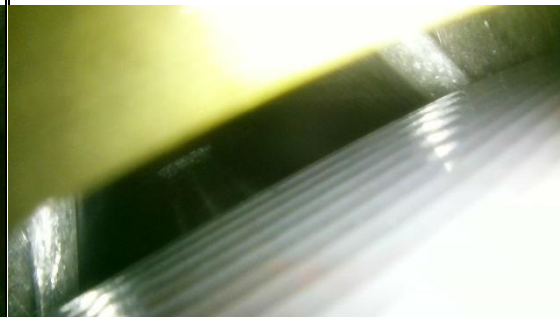
Position:	4 - IMS bearing ROT

Level:	W1-C0-H0

Obs: scoring

There is presence of scoring signs in the surfaces of the bearing.

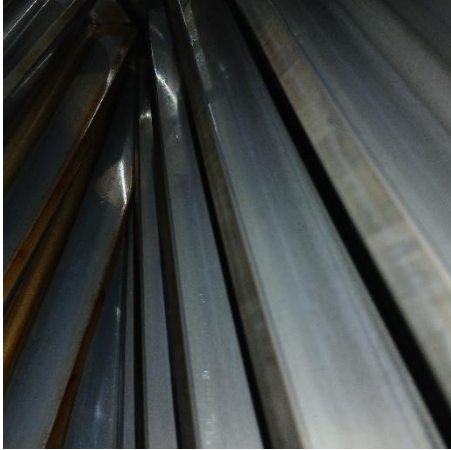
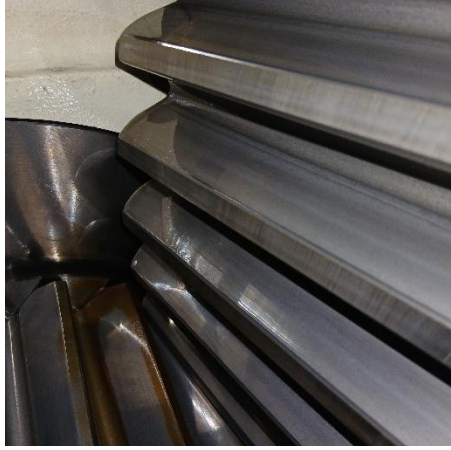
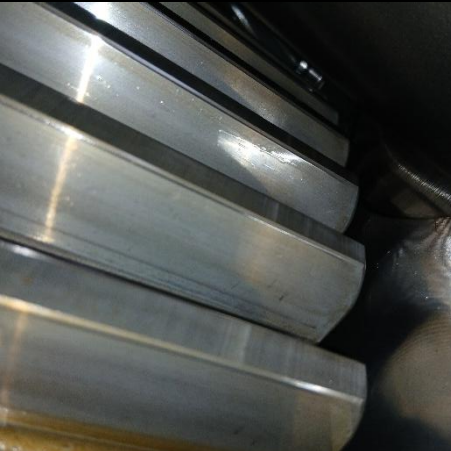
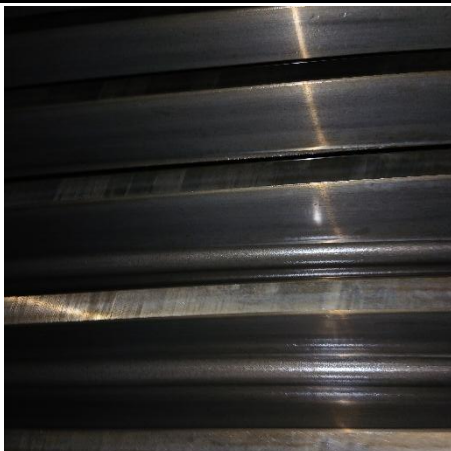
Position:	D - LSS Wheel

Level:	W1-C0-H0

Obs: OK	Obs: OK

Obs: adhesion	Obs: adhesion

There is presence of adhesion signs in the teeth of the gear.

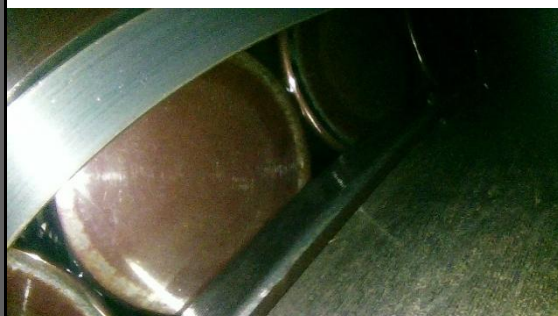
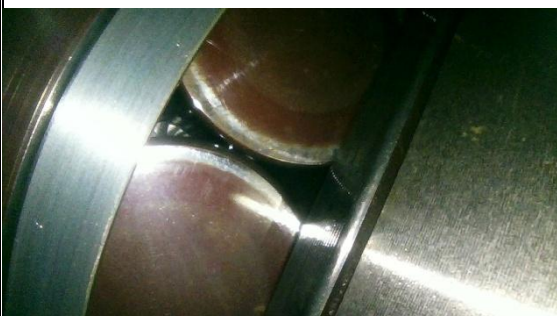
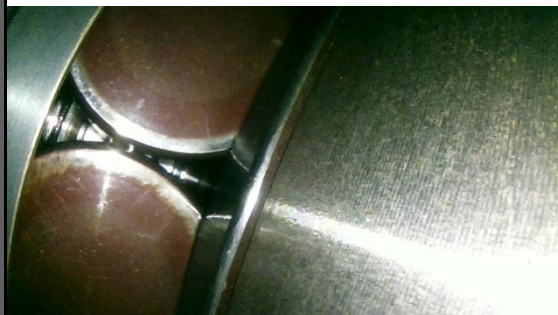
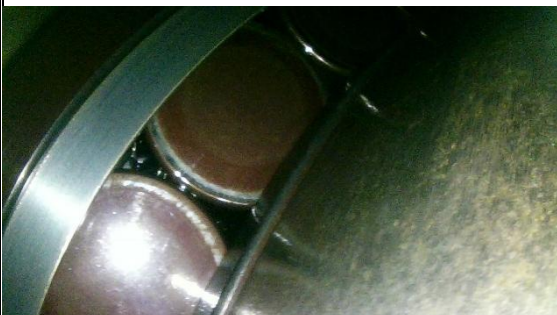
Position:	5 - LSS bearing GEN

Level:	NO ACCESS

No access to the inside of the bearing.

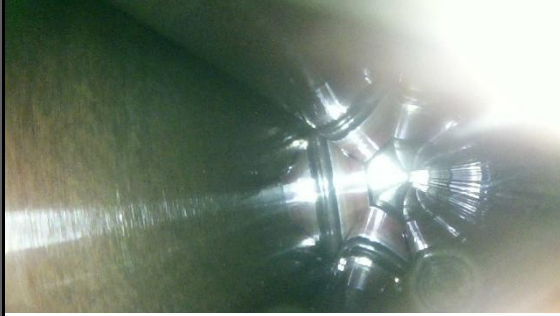
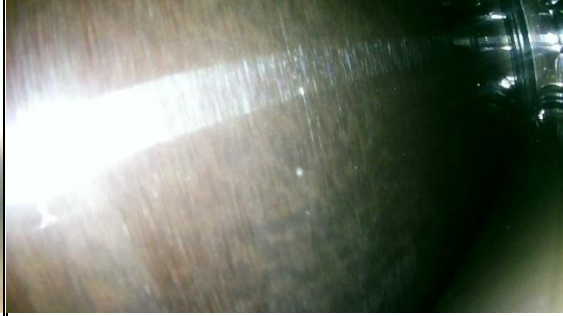
Position:	6 - LSS bearing ROT

Level:	W0-C0-H0

Obs: OK	Obs: OK

No defects have been found.

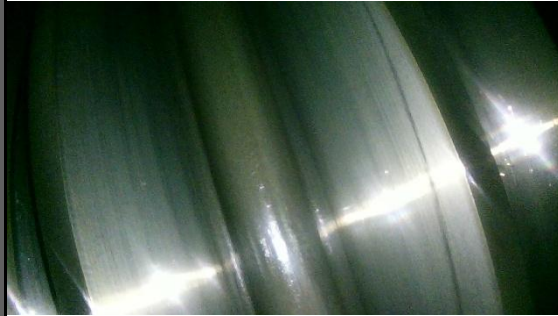
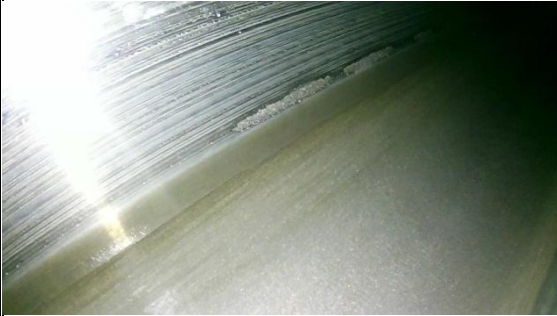
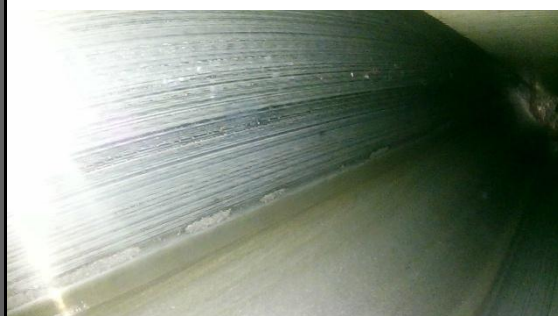
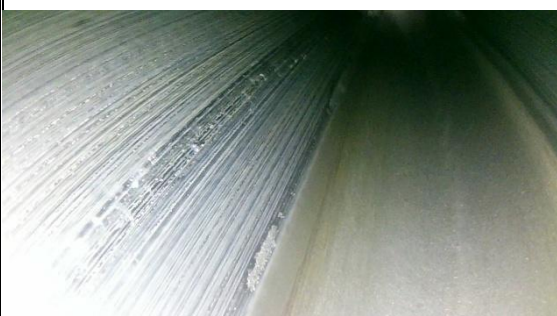
Position:	F - SUN pinion	 
Level:	W1-C0-H1

Obs: standstill marks	Obs: abrasion and micropitting

Obs: abrasion and micropitting	Obs: abrasion and micropitting

There is presence of standstill marks, abrasion and micropitting signs in the teeth of the gear.

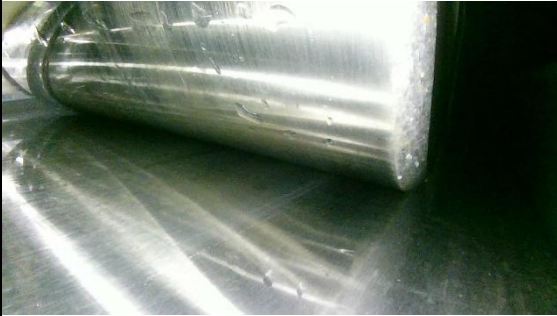
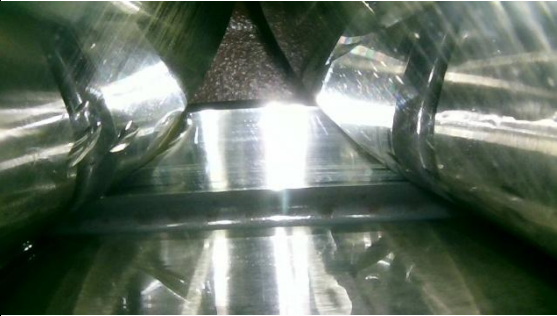
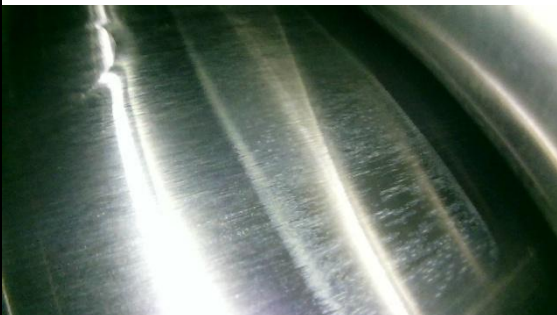
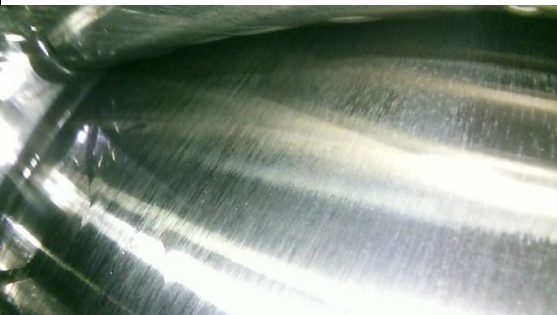
Position:	8 - PC bearing ROT

Level:	W1-C0-H0

Obs: adhesion	Obs: adhesion

Obs: scoring	Obs: scoring

There is presence of adhesion and scoring signs in the surfaces of the bearing.

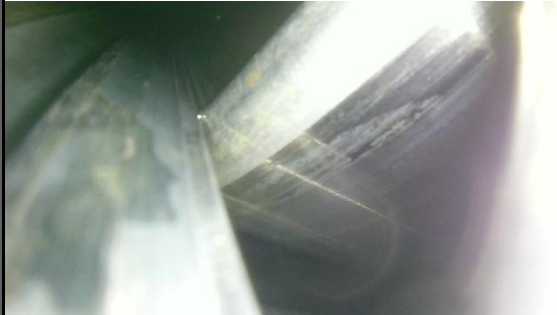
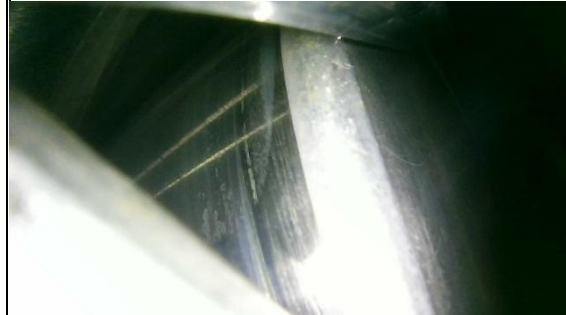
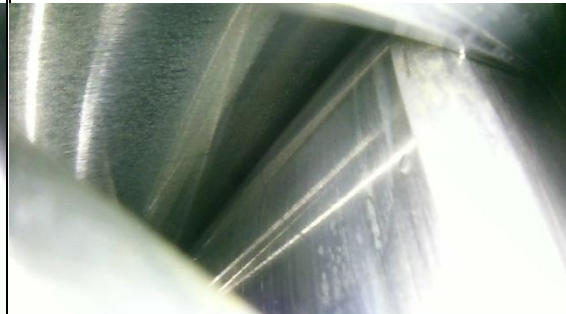
Position:	9- PC bearing GEN

Level:	W1-C0-H0

Obs: scoring	Obs: scoring

There is presence of scoring signs in the surfaces of the bearing.

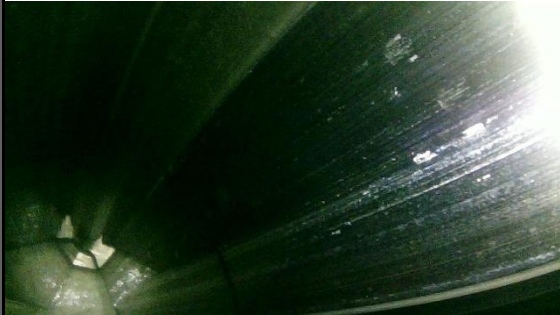
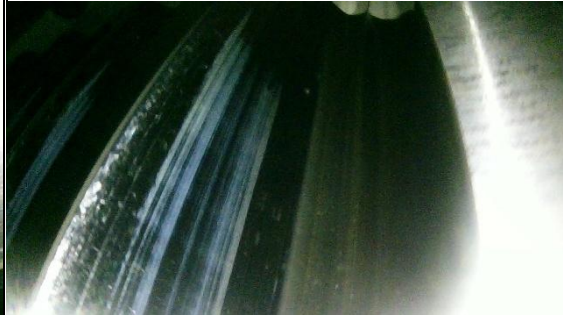
Position:	E - Ring gear	 
Level:	W1-C0-H1

Obs: abrasion and micropitting	Obs: abrasion and micropitting

There is presence of abrasion and micropitting signs in the teeth of the gear.

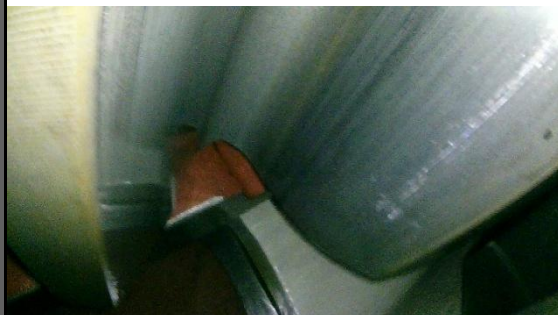
Position:	G.1 - Satellite gear 1	 
Level:	W1-C0-H1

Obs: abrasion and micropitting	Obs: abrasion and micropitting

There is presence of abrasion and micropitting signs in the teeth of the gear.

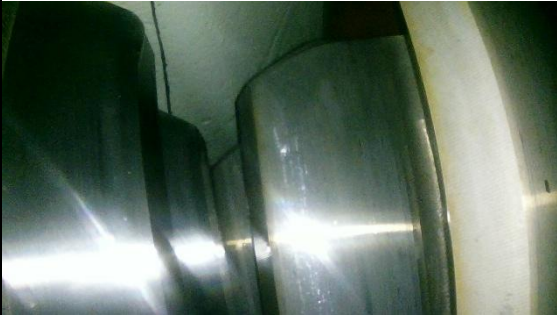
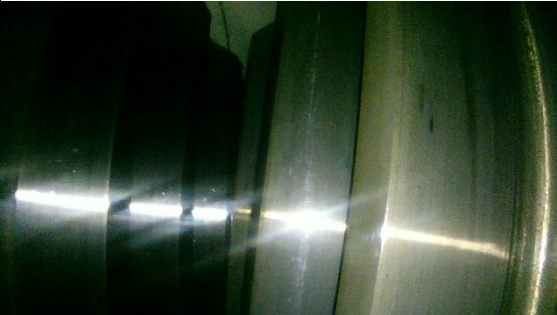
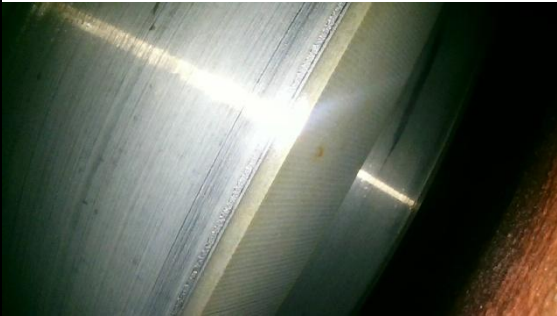
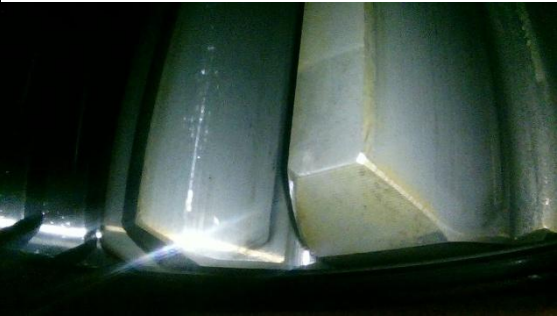
Position:	G.2 Satellite gear 2	 
Level:	W1-C0-H1

Obs: abrasion and micropitting	Obs: adhesion, abrasion and micropitting

Obs: adhesion and micropitting	Obs: abrasion and micropitting

There is presence of adhesion, abrasion and micropitting signs in the teeth of the gear.

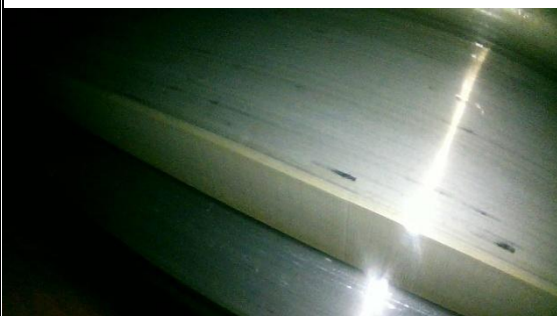
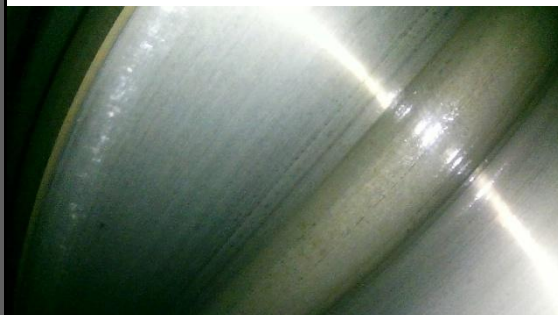
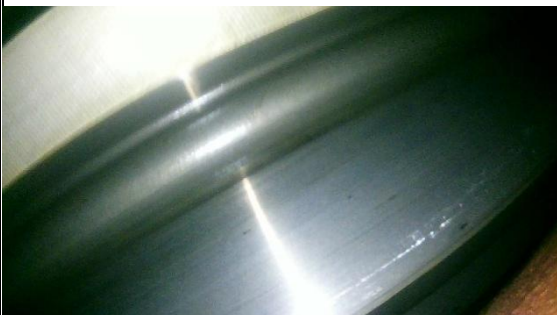
Position:	G.3 - Satellite gear 3	 
Level:	W1-C0-H1

Obs: abrasion and micropitting	Obs: adhesion, abrasion and micropitting

Obs: abrasion and micropitting	Obs: abrasion and micropitting

There is presence of adhesion, abrasion and micropitting signs in the teeth of the gear.

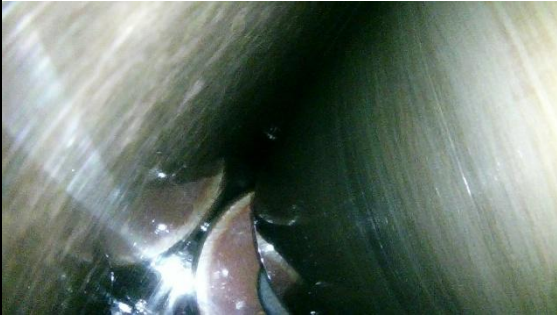
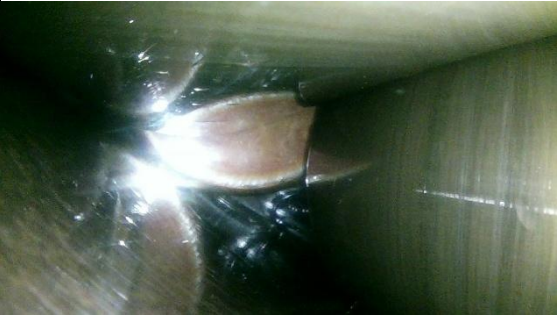
Position:	7.1 - Satellite bearing 1

Level:	W1-C0-H0

Obs: adhesion	Obs: adhesion

There is presence of adhesion signs in the surfaces of the bearing.

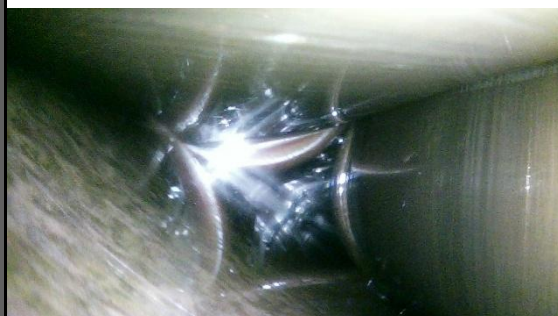
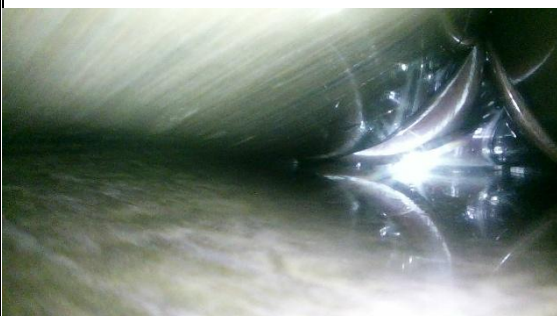
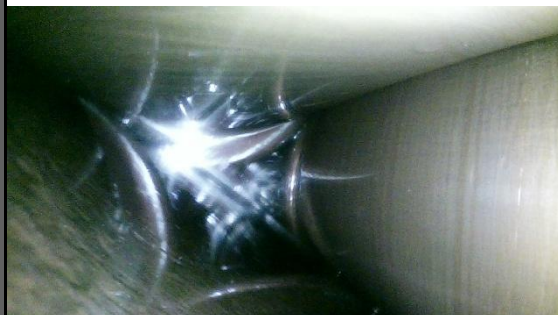
Position:	7.3 - Satellite bearing 3

Level:	W1-C0-H0

Obs: adhesion	Obs: adhesion

There is presence of adhesion signs in the surfaces of the bearing.
