# Gearbox Borescope Inspection

Ventos Metódicos Warehouse

WTG 2

Author	Daniel Fuentes Moncayo
Date	07/11/2025
Ref.	VMW_002_2025-11-07_GBB

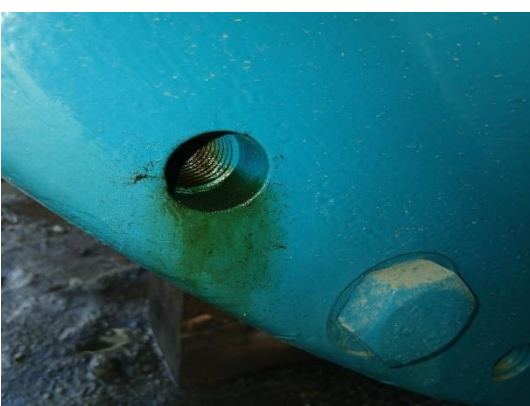
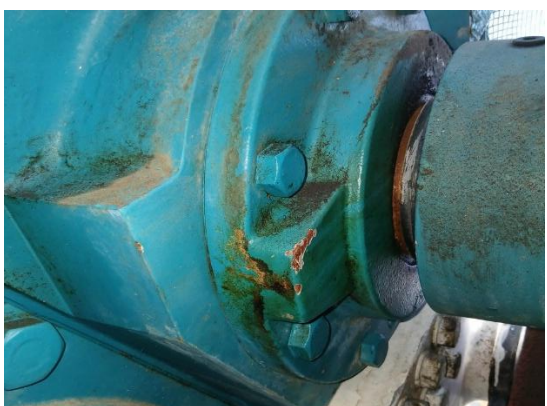
REMARKS	
6	Low oil level
9	Oil leaks

Obs: Oil leaks		MD	Obs: Oil leaks

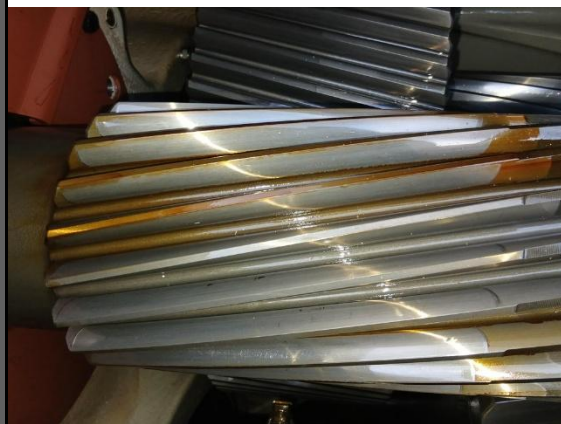
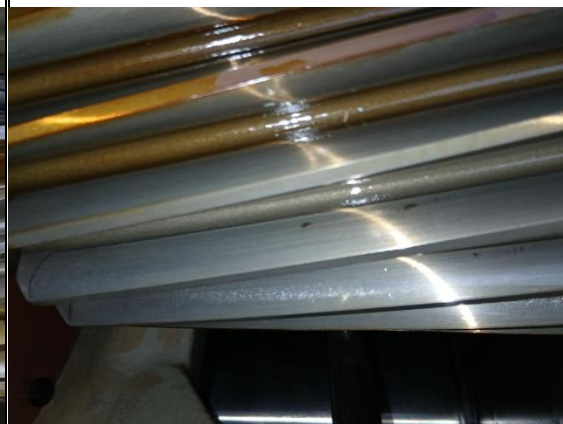
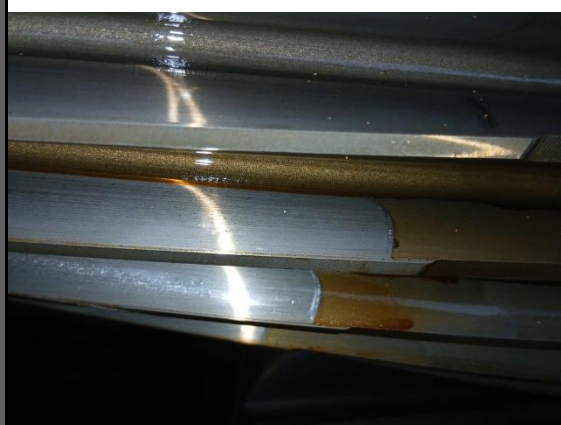
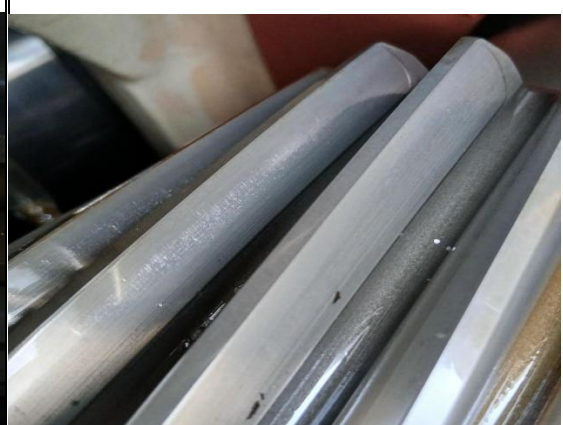
Position:	A - HSS pinion

Obs: adhesion, abrasion and micropitting

There is presence of adhesion, abrasion and micropitting signs in the teeth of the gear.

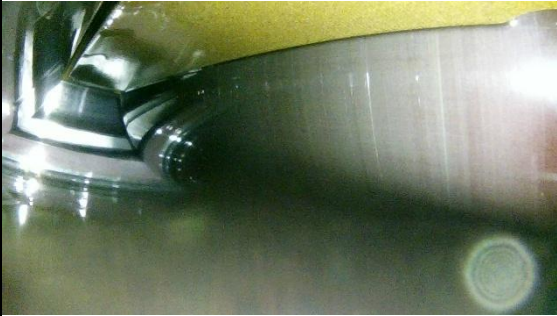
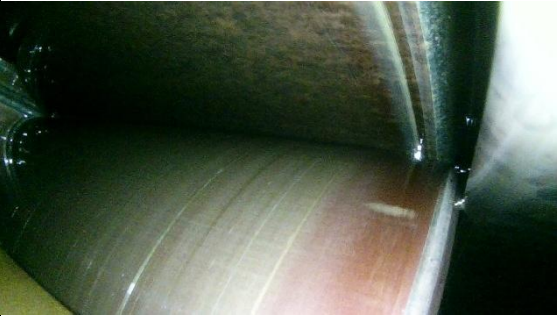
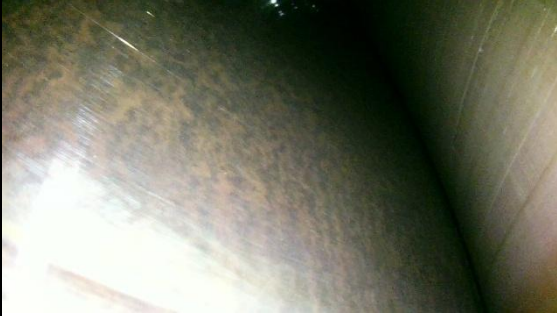
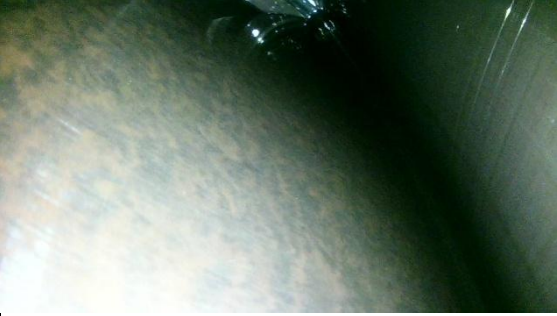
Position:	2 - HSS bearing ROT

Obs: adhesion	Obs: adhesion

There is presence of adhesion signs in the surfaces of the bearing.

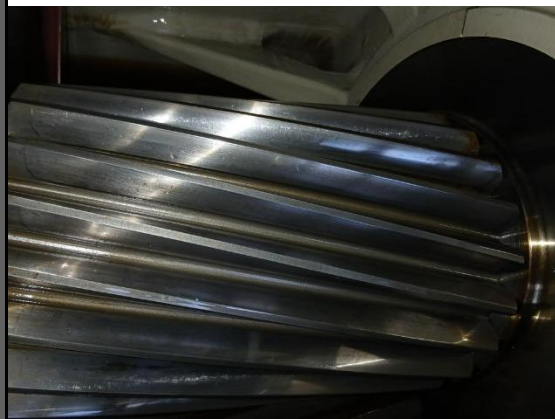
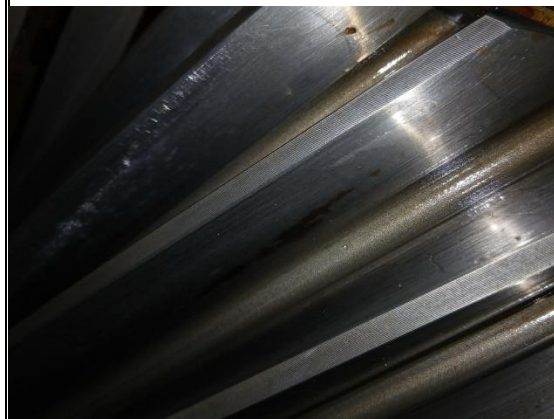
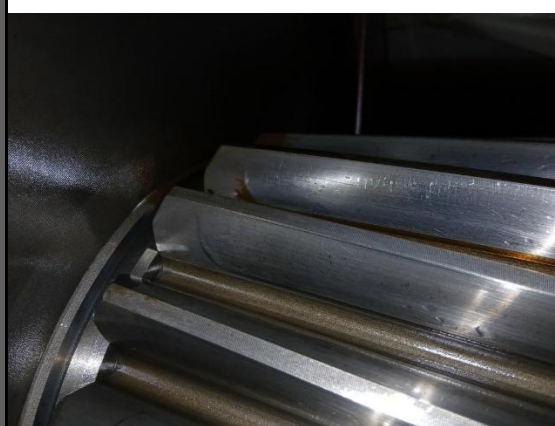
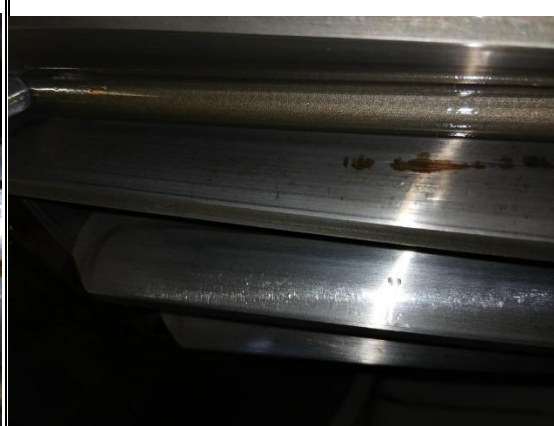
Position:	C - ISS pinion

Obs: abrasion and micropitting

Obs: adhesion, abrasion and micropitting

There is presence of adhesion, abrasion and micropitting in the teeth of the gear.

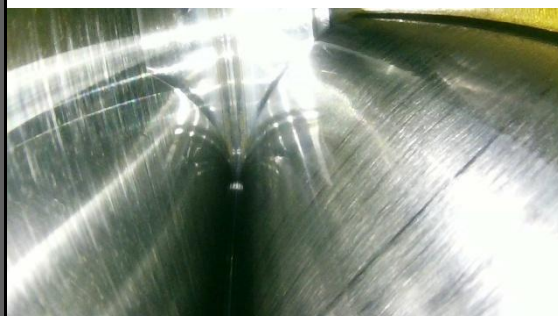
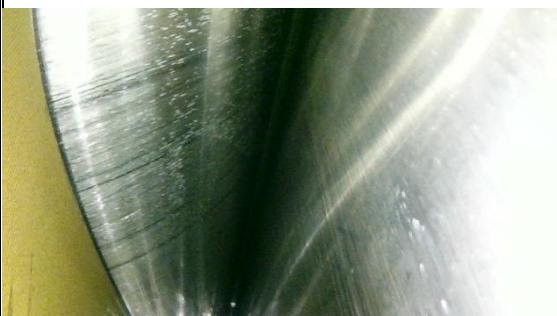
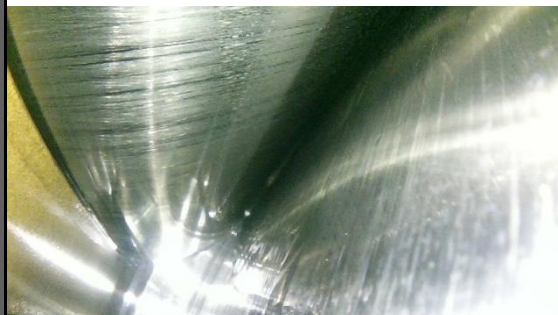
Position:	3 - IMS bearing GEN

Obs: adhesion and scoring	Obs: adhesion and scoring

There is presence of adhesion and scoring signs in the surfaces of the bearing.

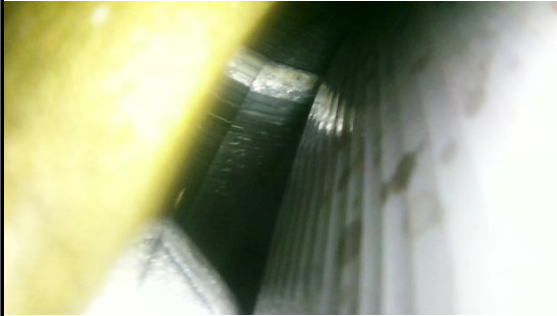
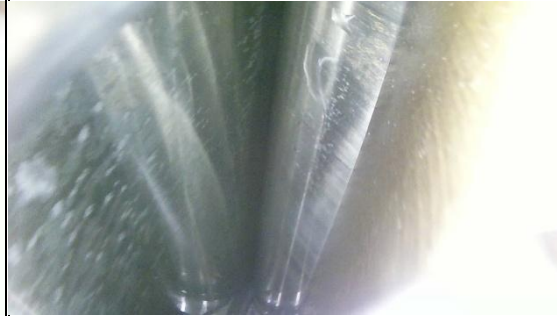
Position:	4 - IMS bearing ROT

Obs: scoring

There is presence of scoring signs in the surfaces of the bearing.

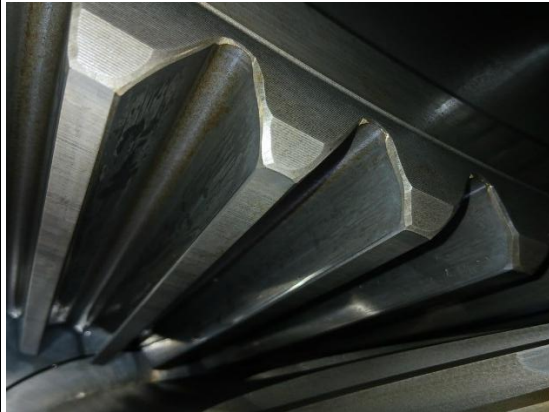
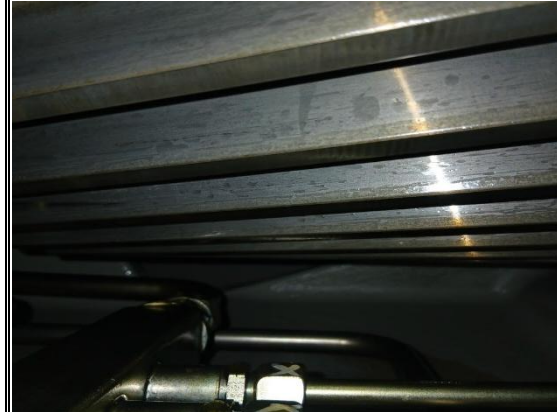
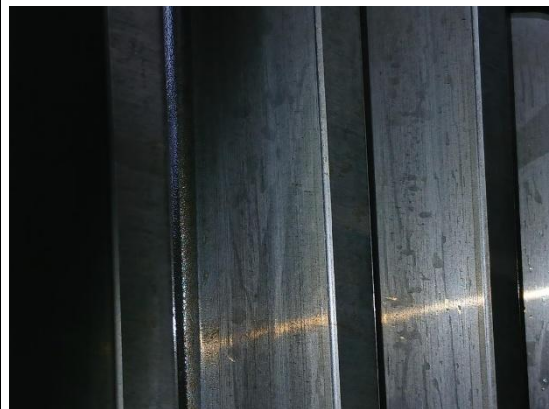
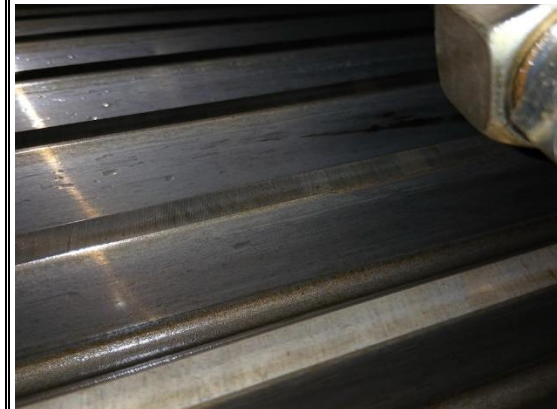
Position:	D - LSS Wheel

Obs: adhesion

There is presence of adhesion signs in the teeth of the gear.

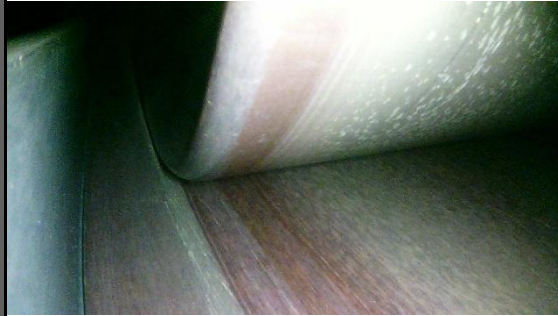
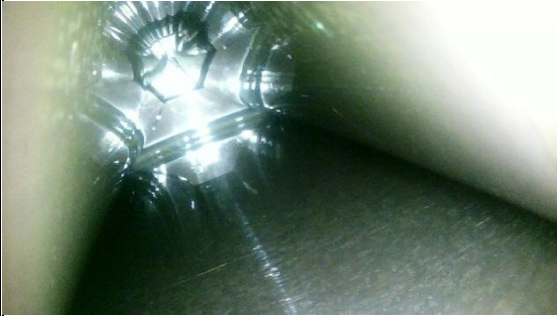
Position:	6 - LSS bearing ROT

Obs: scoring	Obs: scoring

There is presence of scoring signs in the surfaces of the bearing.

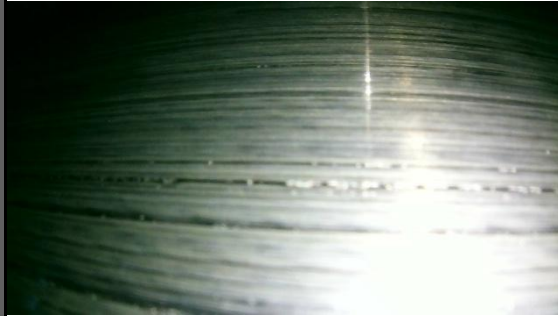
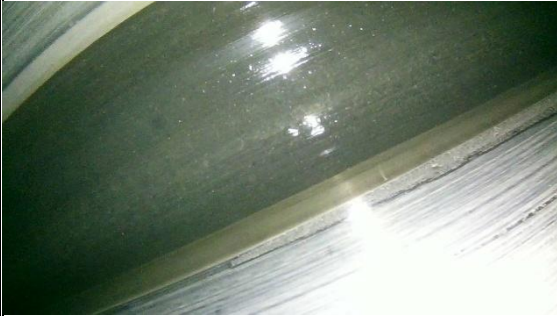
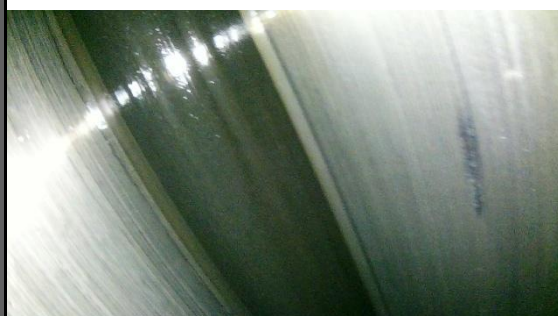
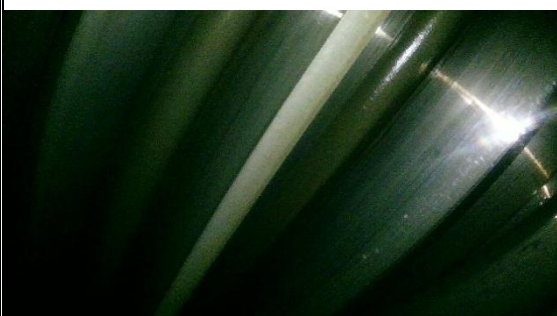
Position:	F - SUN pinion

Obs: micropitting	Obs: micropitting

Obs: adhesion and micropitting	Obs: abrasion and micropitting

There is presence of adhesion, abrasion and micropitting signs in the teeth of the gear.

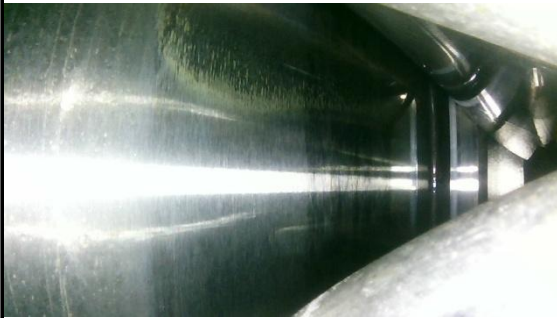
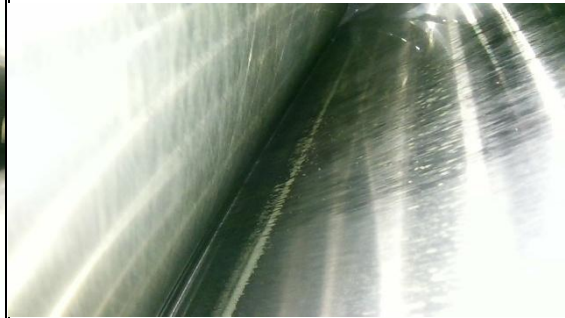
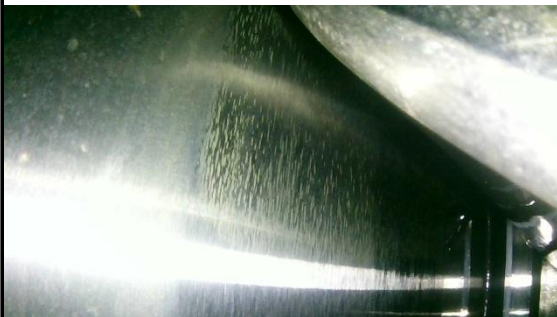
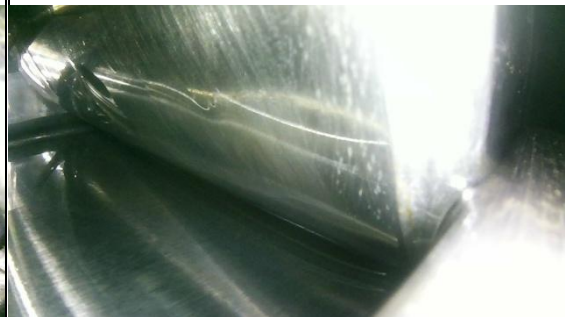
Position:	8 - PC bearing ROT

Obs: scoring

There is presence of scoring signs in the surfaces of the bearing.

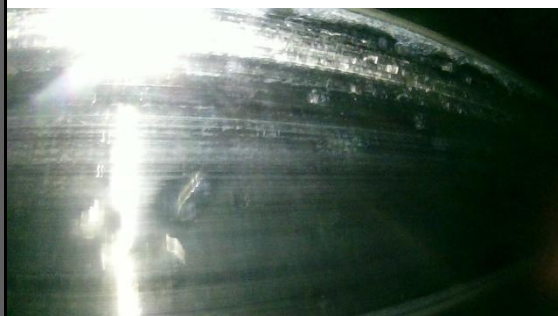
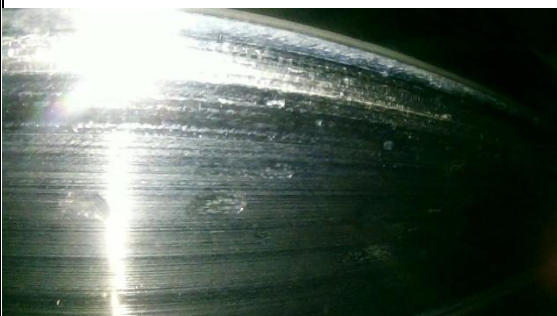
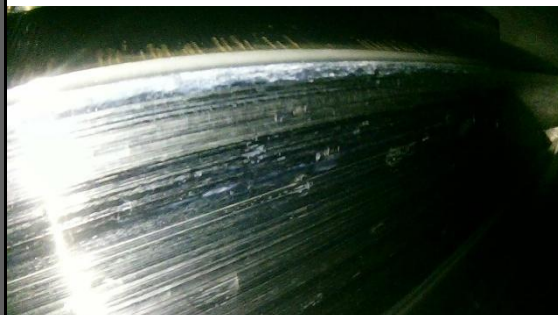
Position:	E - Ring gear	 
Level:	W1-C0-H1

Obs: abrasion and micropitting	Obs: abrasion and micropitting

Obs: abrasion and micropitting	Obs: adhesion

There is presence of adhesion, abrasion and micropitting signs in the teeth of the gear.

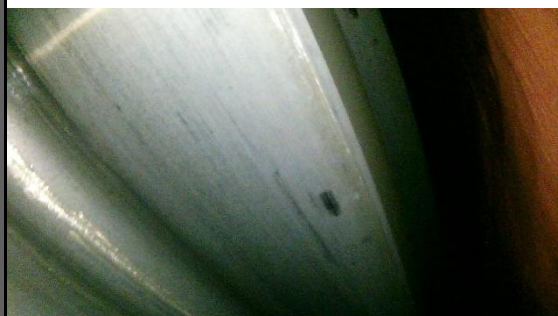
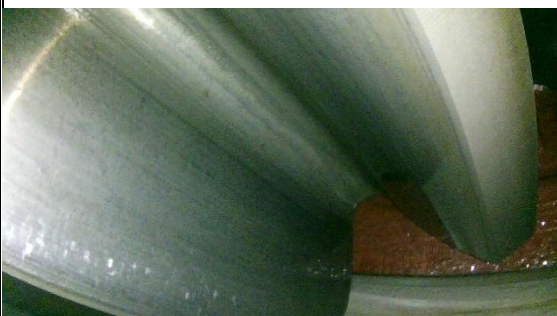
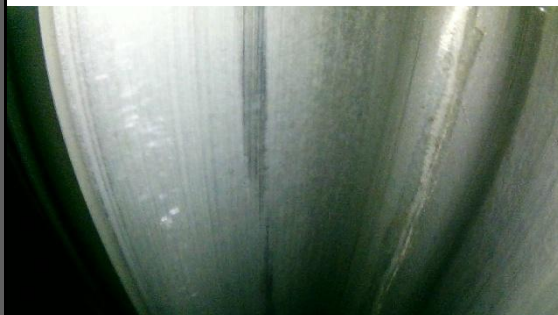
Position:	G.1 - Satellite gear 1	 
Level:	W1-C0-H0

Obs: abrasion and adhesion	Obs: abrasion

Obs: abrasion and standstill marks	Obs: abrasion and standstill marks

There is presence of standstill marks, abrasion and adhesion signs in the teeth of the gear.

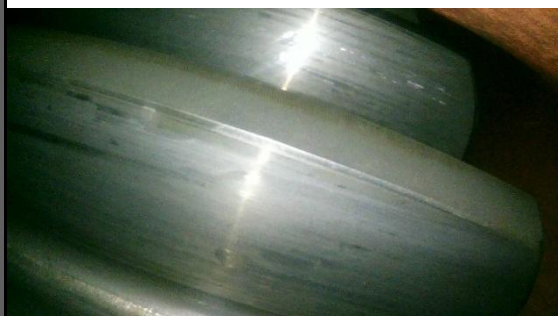
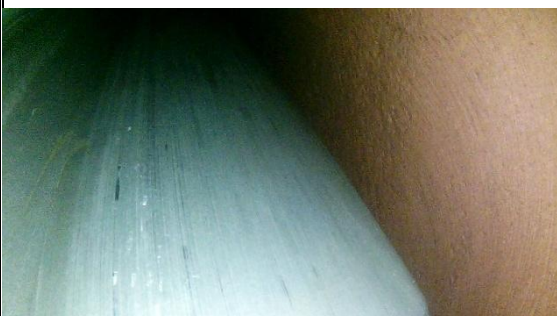
Position:	G.2 Satellite gear 2	 
Level:	W1-C0-H0

Obs: adhesion and abrasion	Obs: adhesion and abrasion

There is presence of adhesion and abrasion signs in the teeth of the gear.

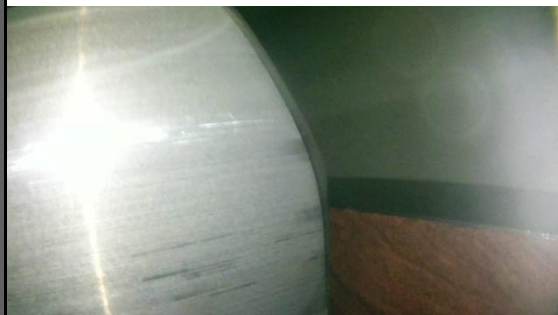
Position:	G.3 - Satellite gear 3	 
Level:	W1-C0-H0

Obs: adhesion and abrasion	Obs: adhesion

There is presence of adhesion and abrasion signs in the teeth of the gear.
