**R\_240219/2**

## **Work report**

**Rotor blade set LM 37.3P**

**Bl. Nr. 332 DK, 289 DK, 326 DK**

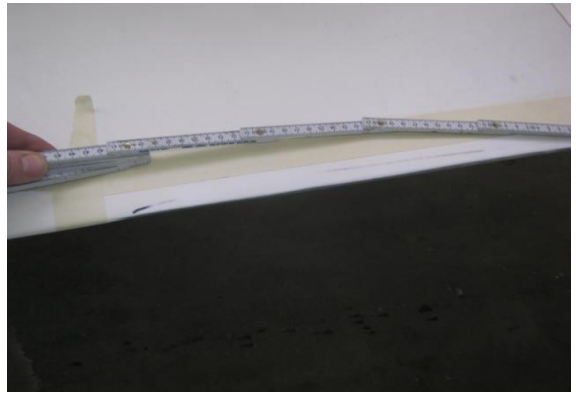
Bild 1

| Pos. | | Pressure side | | Suction side | | Pos. |
|---|---|---|---|---|--|---|
| 1 | R2,5 VK chipper Ø 1cm<br>Rep: sanded & varnished<br>Image: 1 | | 0,0 | | | |

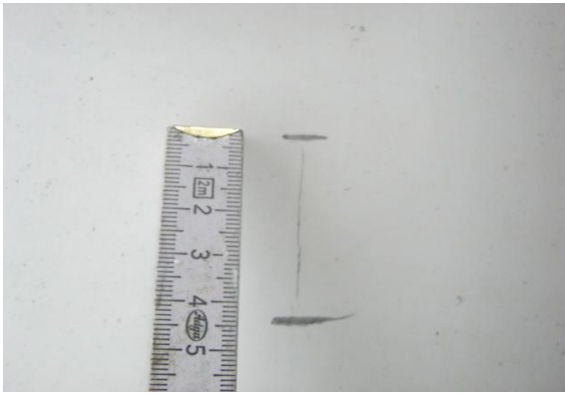
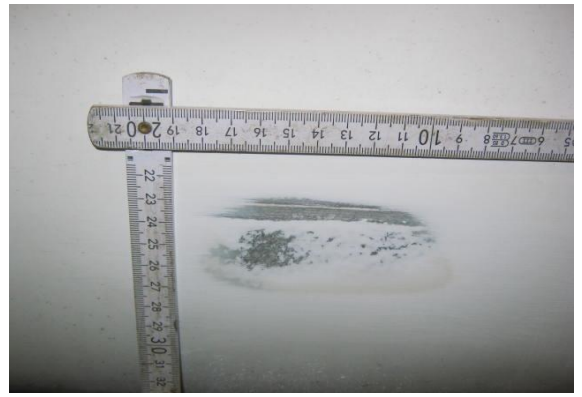
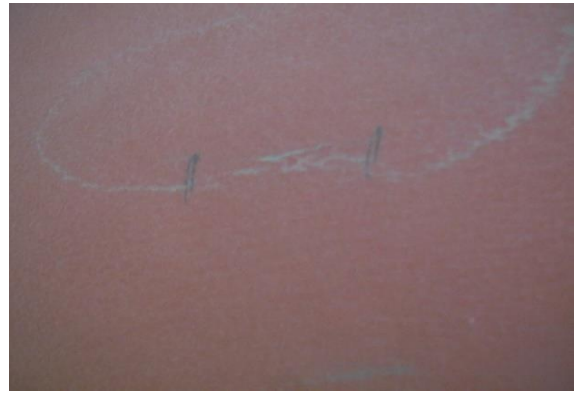
| Pos. | Pressure side | | Suction side | Pos. |
|---|---|---|---|---|
| 1 | R11 VK LR L= 4,5cm<br>Rep: sanded & varnished<br>Image: 1-3 | 9,0 | | |

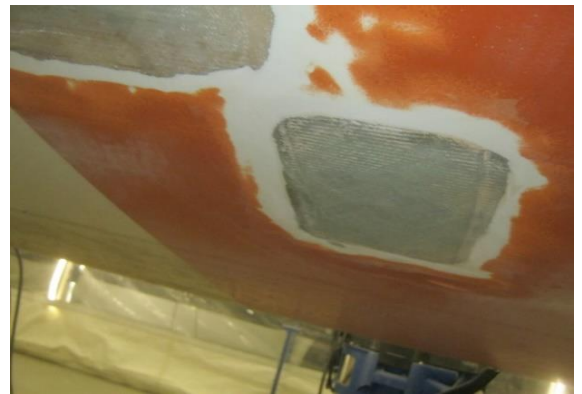
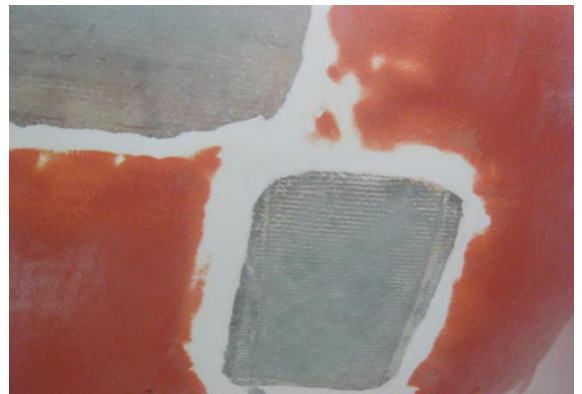
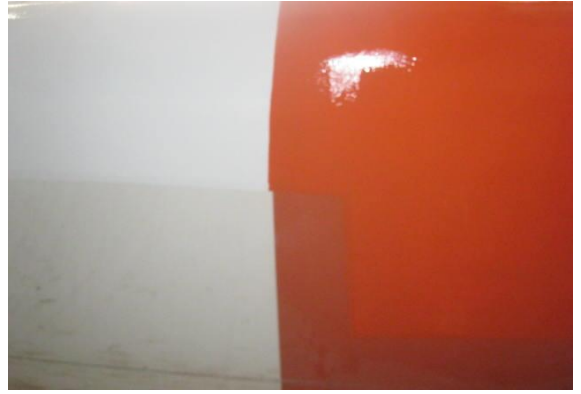
| Pos. | Pressure side | | Suction side | Pos. |
|---|---|---|---|---|
| 2 | R25 DS QR L= 5cm<br>Rep: sanded, 3-ply laminated filled,<br>sanded and varnished<br>Image: 4-10 | 20,0 | | |

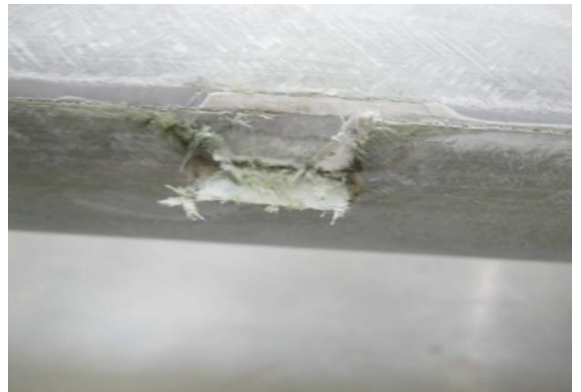
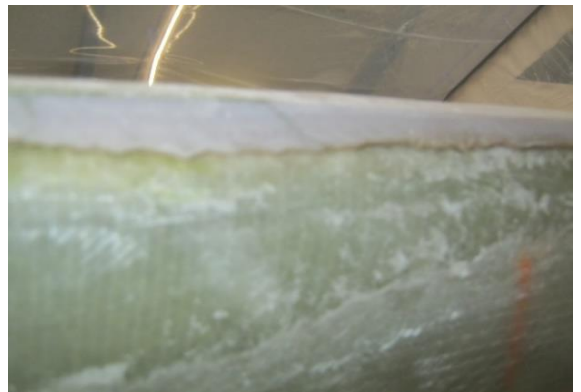
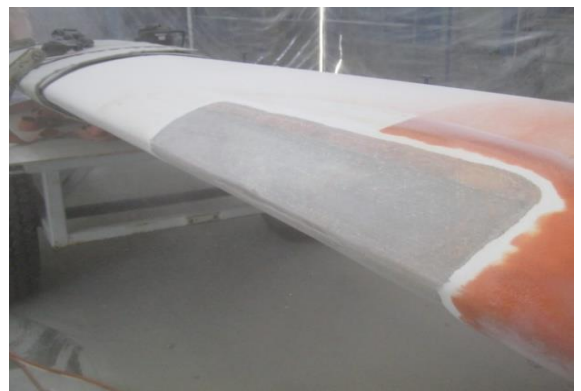
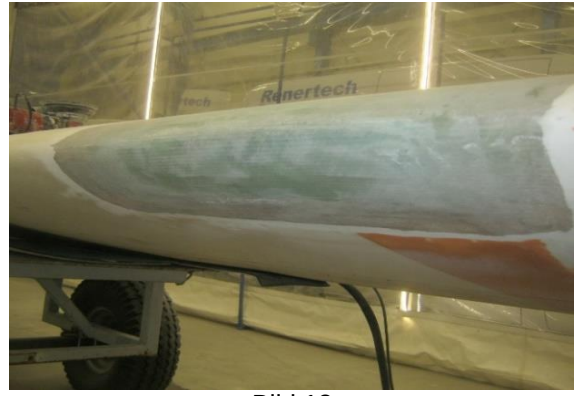
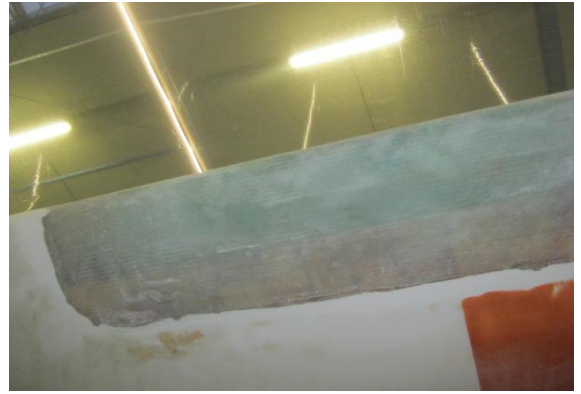
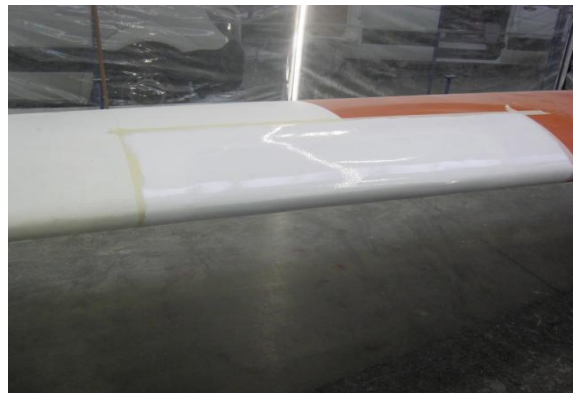
| Pos. | Pressure side | | Suction side | Pos. |
|---|---|---|---|---|
| 3 | R26-R27 VK longitudinal crack L= 40cm and chipping 10x5cm<br>Rep: sanded, 5-ply laminated filled,<br>sanded and varnished<br>Image: 11-23 | 25,0 | | |

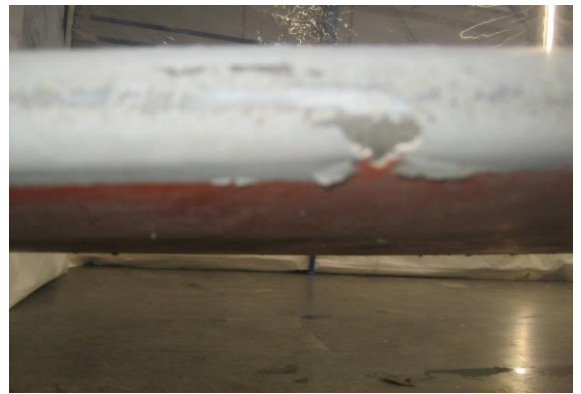
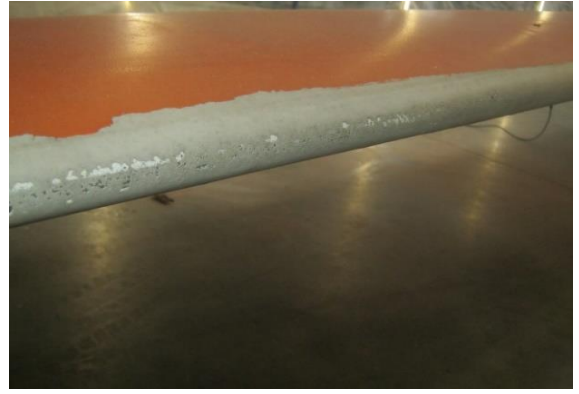
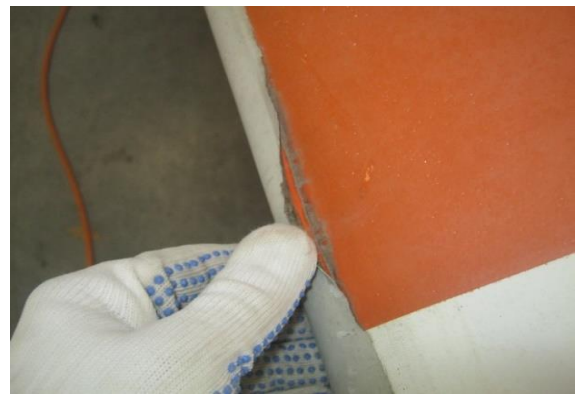
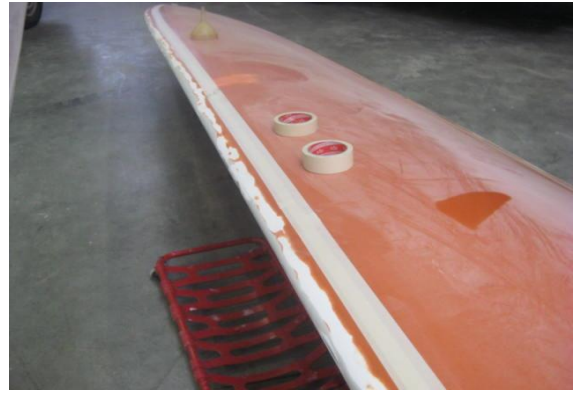
| Pos. | Pressure side | | Suction side | Pos. |
|---|---|---|---|---|
| 4 | R25-R37 VK Erosion, chipping & damaged E-foil<br>Rep: sanded, troweled, sanded & new paintable E-foil applied<br>Image: 24-40 | 33,0 | | |

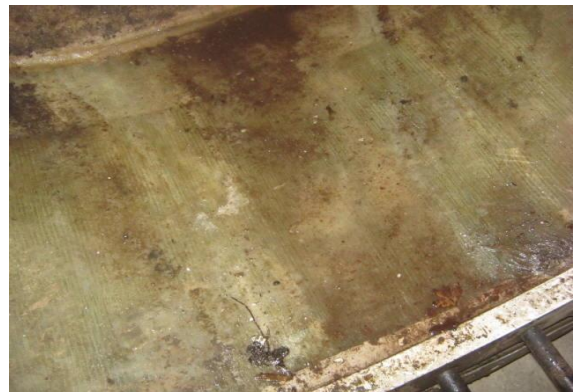
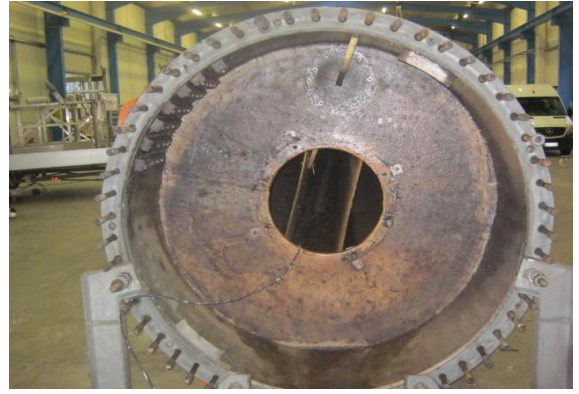
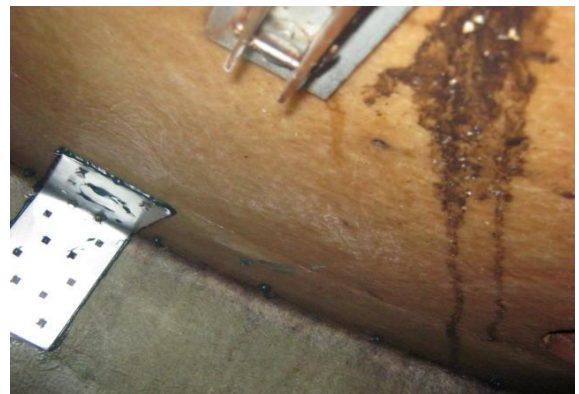
Sheet inside report:SS/HK/VK entry shot on approx. 3/4 of the circumference loose and broken. Areas cleaned & shot reinforced with angle. Image: 56-62

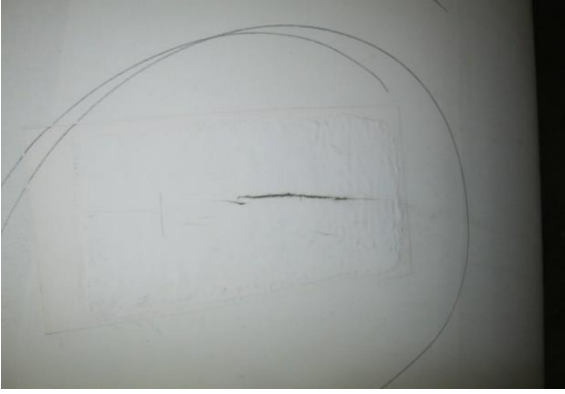
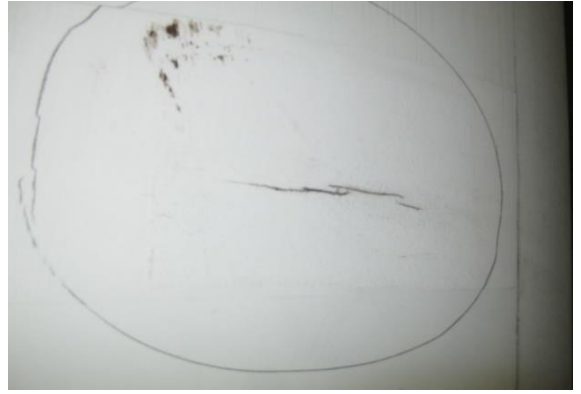
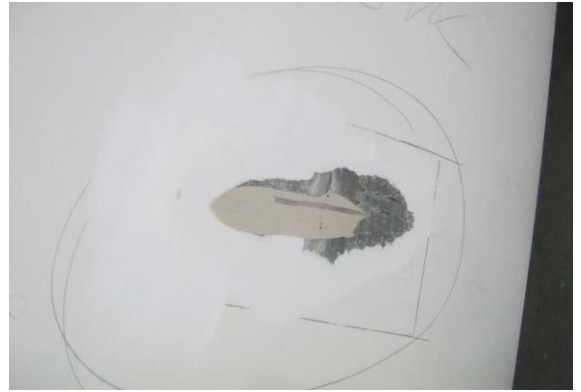
| Pos. | Pressure side | Suction side | Pos. |
|---|---|---|---|
| 1 | R8-R9 VK 2QR L= 8-9cm<br>Rep: sanded, filled, sanded & varnished<br>Image: 1-6 | 7,0 | |

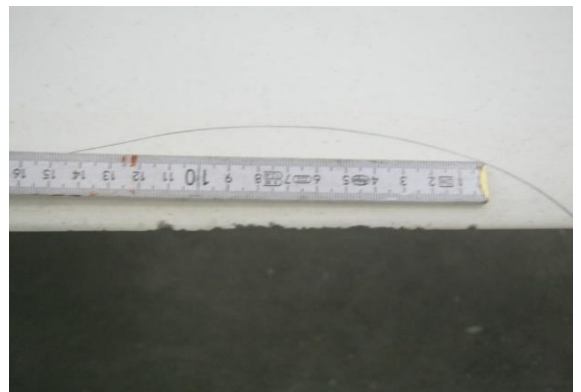
| Pos. | Pressure side | Suction side | Pos. |
|---|---|---|---|
| 2 | R15-R16 HK Chipped<br>Rep: sanded & varnished<br>Image: 7-8 | 14,0 | |

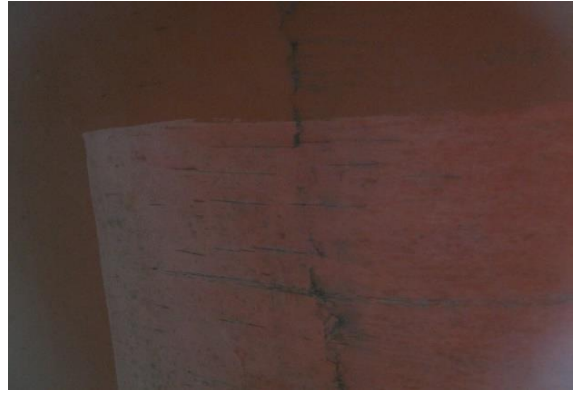
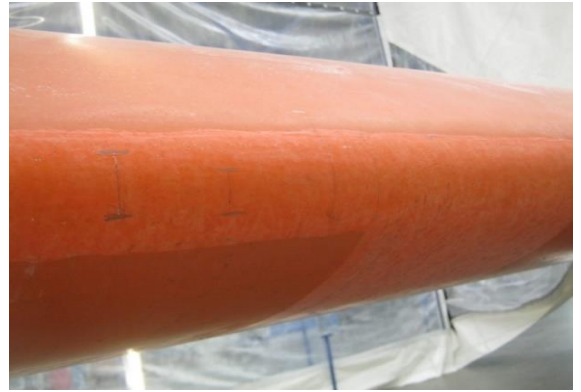
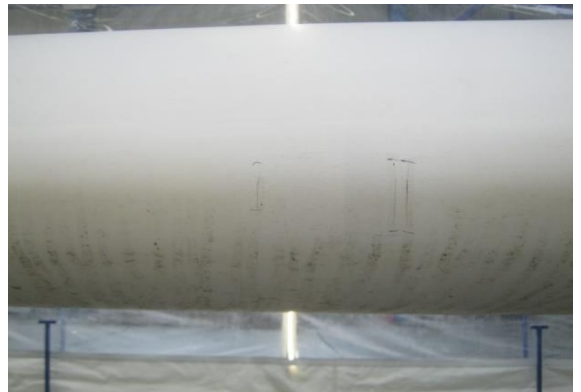
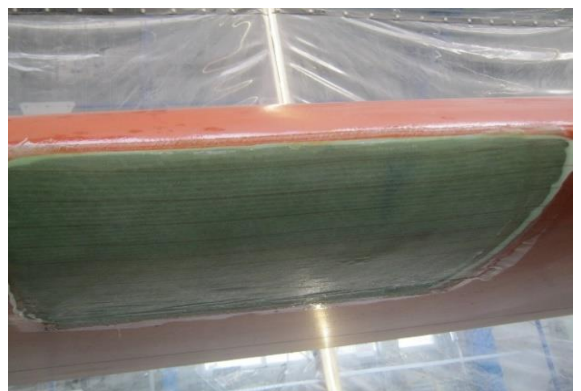
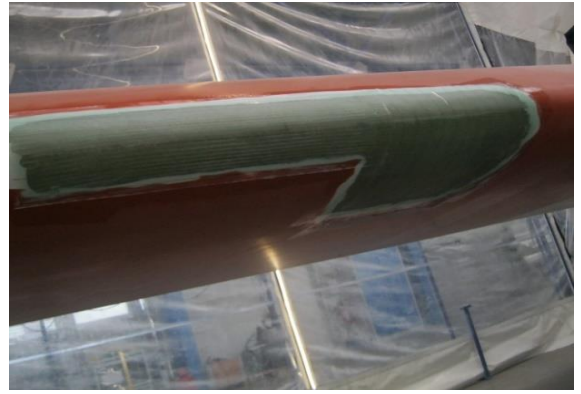
| Pos. | Pressure side | Suction side | Pos. |
|---|---|---|---|
| 3 | R17-R23 VK 2QR L= 8-9cm<br>Rep: sanded, 3-ply laminated, filled, sanded and varnished<br>Image: 9-19 | 17,0 | |

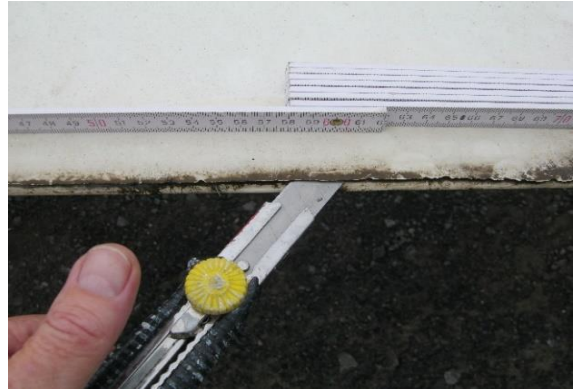
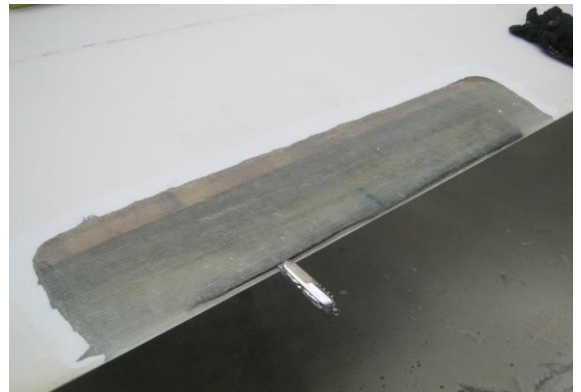
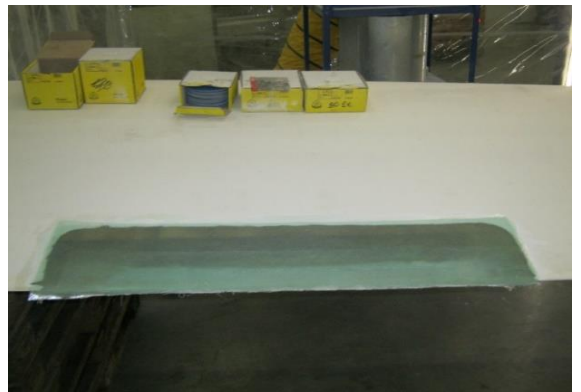
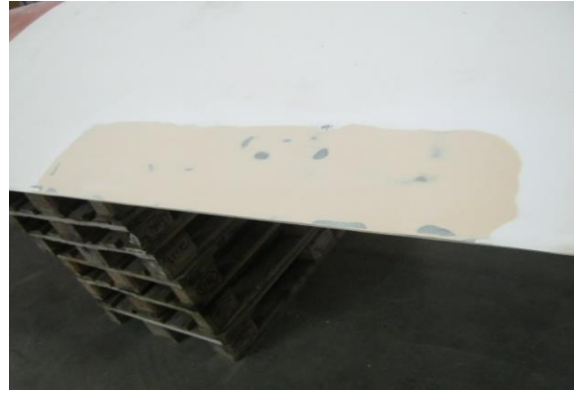
| Pos. | Pressure side | Suction side | Pos. |
|---|---|---|---|
| 4 | R25-R26 HK on L= 75cm open<br>Rep: sanded, 5-ply laminated, filled, sanded and varnished<br>Image: 20-26 | 24,0 | |

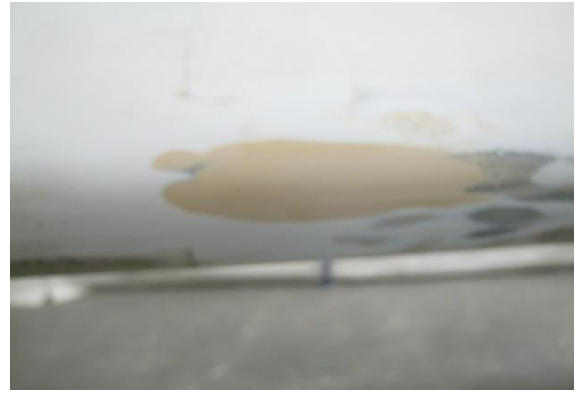
| Pos. | Pressure side | Suction side | Pos. |
|---|---|---|---|
| 5 | R27 VK 1LR L= 4cm<br>Rep: sanded, filled, sanded & varnished<br>Image: 27-28 | 27,0 | |

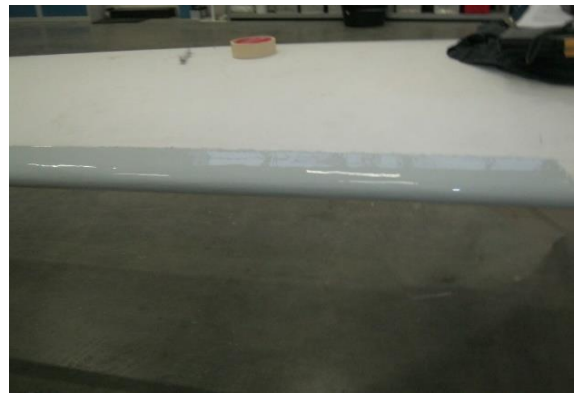
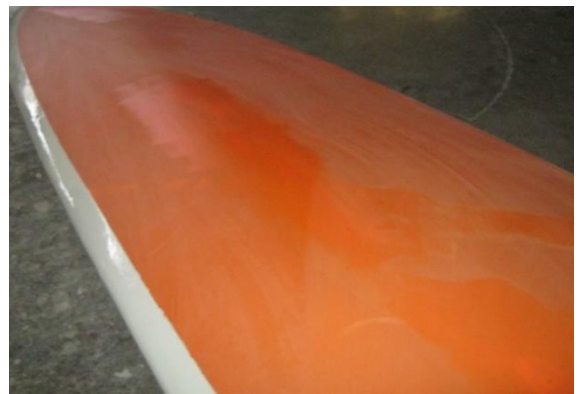
| Pos. | Pressure side | Suction side | Pos. |
|---|---|---|---|
| 6 | R33-R37 VK Paint Chipping & Erosion & Damaged E-Foil<br>Rep: sanded, troweled, sanded & new paintable E-foil applied<br>Image: 29-33 | 35,0 | |

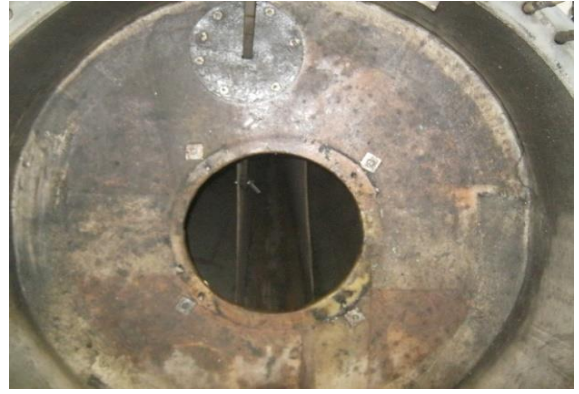
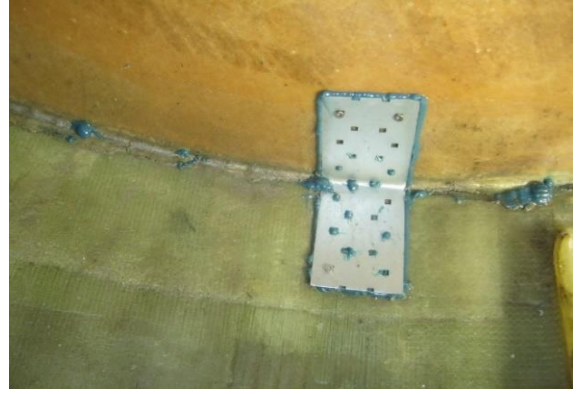
Sheet inside report: SS/HK/VK entry shot loose & broken on half of the circumference. Areas cleaned & shot reinforced with angle. Image: 34-45

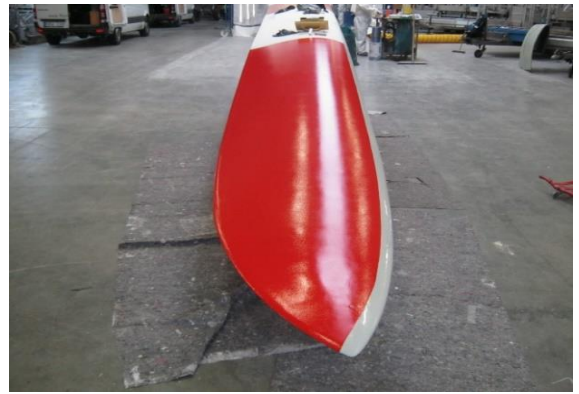
Signal markings on the blades repainted in RAL 3020. Image: 46-48
