## REPAIR REPORT

**GENERATOR ABB**

**TIPO HXR 500LN4/6**

**1300/250 KW 690/690 V 1510/1008 RPM 1219/248 A**

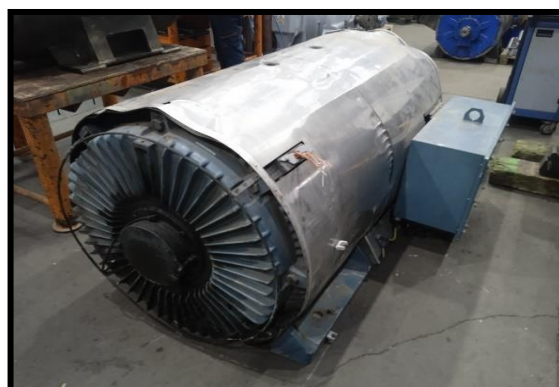
- Need overhaul.

Fig. 2. Entry into workshop.

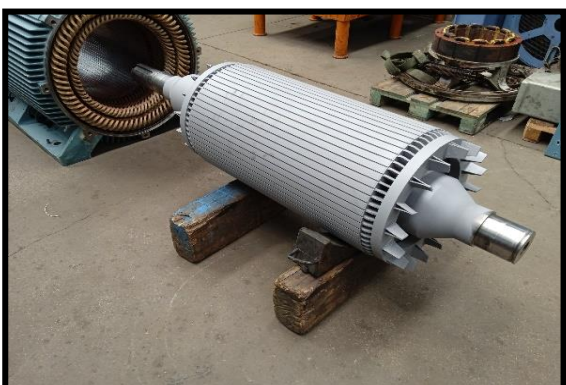
Fig. 3. Rotor treatment

- Stator Winding Inspection
- Descaling and heating of the stator.
- Verification of temperature probes and heating resistors.
- Descaling and heating of the rotor.
- Supply and installation of new FAG 6326-C3 & 6324-C3 bearings.
- Verification Dynamic balancing of the rotor assembly.
- Assembly of components.
- Repainting of the set and packaging.
- Final Dielectric and Rolling Bench Tests. Issuance of repair report.

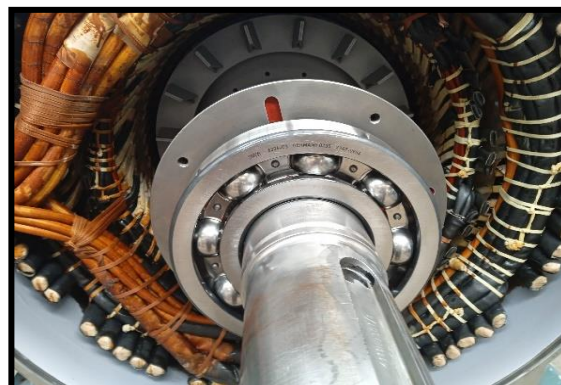
Fig. 4. DE Bearing renewal.

| BEARING | ORIGIN | MOUNTED |
|---|---|---|
| DE SIDE | 6326 C3 | FAG 6326 C3 |

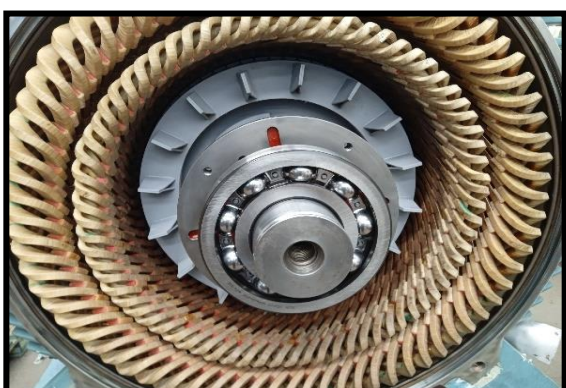
Fig. 5. NDE Bearing renewal (Isolated).

| BEARING | ORIGIN | MOUNTED |
|---|---|---|
| NDE SIDE | 6324 C3 | FAG 6324 C3 |

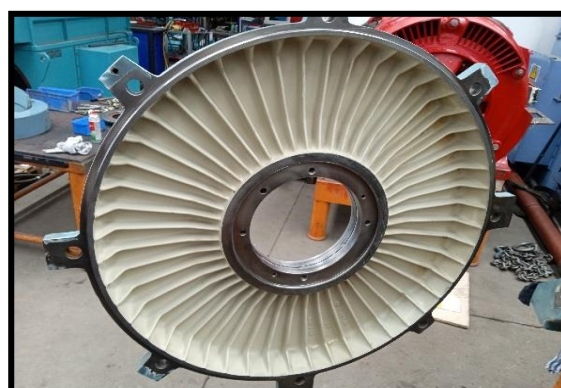
Fig. 6. Treatment of mechanical breakdowns.

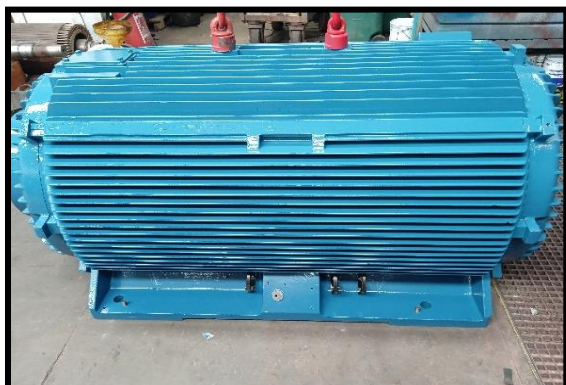
Fig. 7. Finish
