Blade Repair Report

Losheim II
Turbine 204730
Local Turbine ID Lo3
Blade Serial 78120402WHBD26204

Site	Losheim II
Wind Turbine Type	V90
Wind Turbine Number	204730
Wind Turbine Local ID	Lo3
Blade Manufacturer	Vestas Blades
Blade Length (m)	44
Blade Serial	78120402WHBD26204
Blade Index	A
Repair Date (DD/MM/YYYY)	10/05/2023
Report Creator	prm

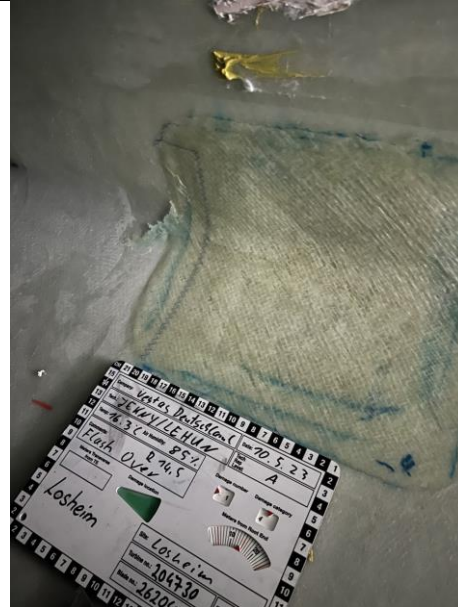
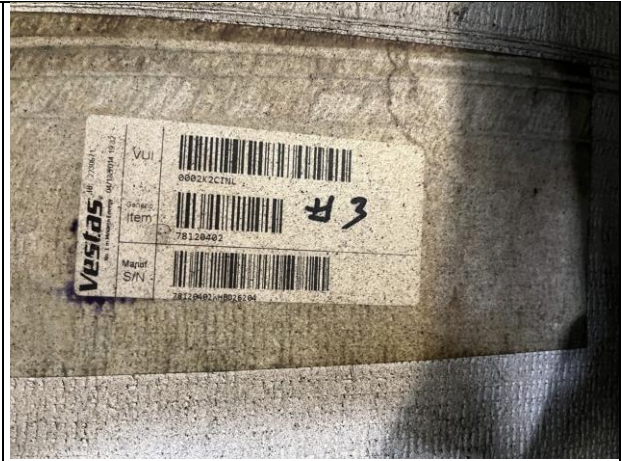
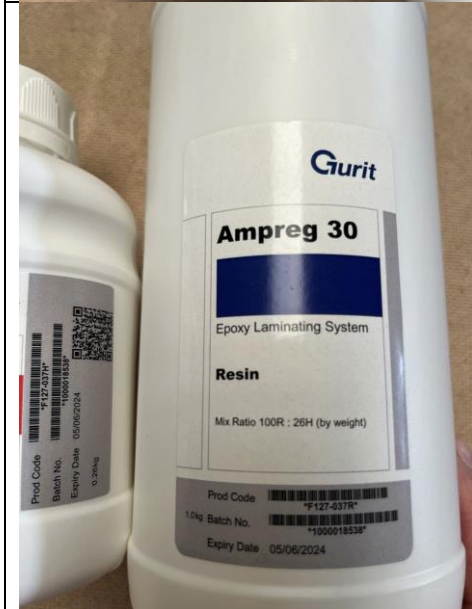
2) Glass Lamination

Damage No. 1

Glass fabric lamination

Max CW (mm)	200	Max SW (mm)	300
Number of Layers	4	Description of Layers (ex. Biax 936gsm Biax600, Triax1200)

Structural repair resin

Resin Type	Ampreg 30		
Resin Batch Number	10000018538	Resin Expiration (DD/MM/YYYY)	05/06/2024
Hardener Type	Ampreg 3X Standard		
Hardener Batch Number	10000018538	Hardener Expiration (DD/MM/YYYY)	05/06/2024

Cure cycle

Cure time (min)	300	Cure temp Start (°C)	20
Cure temp Mid (°C)	66	Cure temp End (°C)	75

CIR approved.
