**R\_240219/2**

## **Work report**

**Rotor blade set LM 37.3P**

**Bl. Nr. 332 DK, 289 DK, 326 DK**

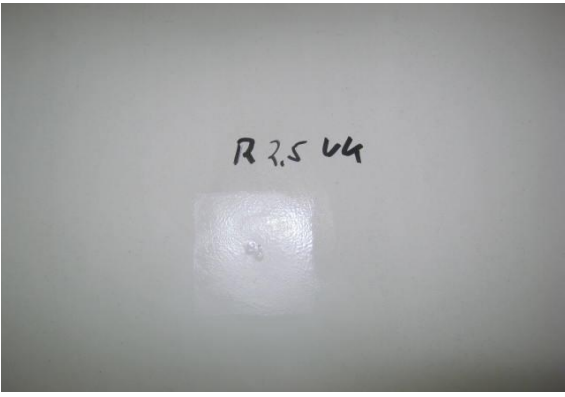
Bild 1

| Pos. | | Pressure side | | Suction side | | Pos. |
|---|---|---|---|---|--|---|
| 1 | R2,5 VK chipper Ø 1cm<br>Rep: sanded & varnished<br>Image: 1 | | 0,0 | | | |

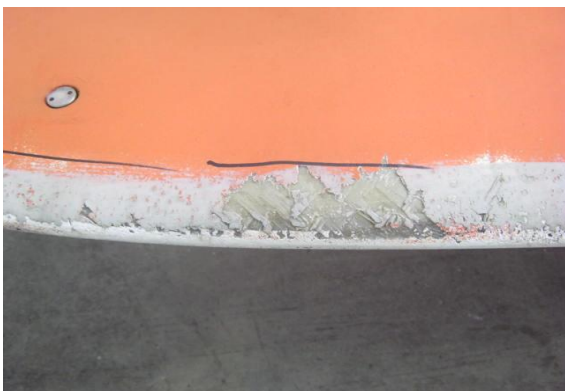
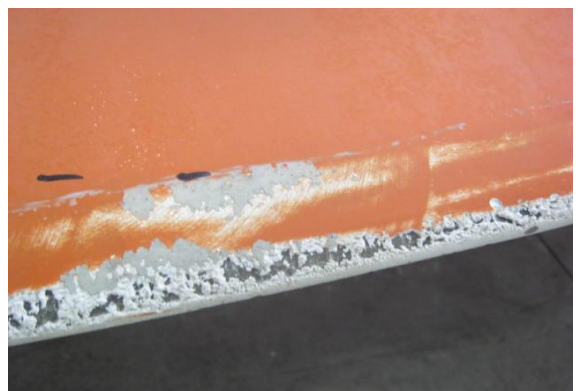
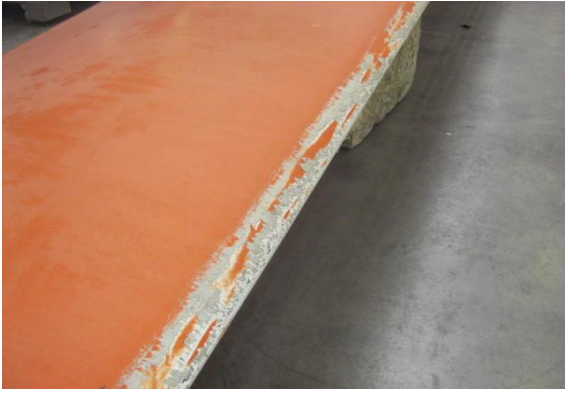
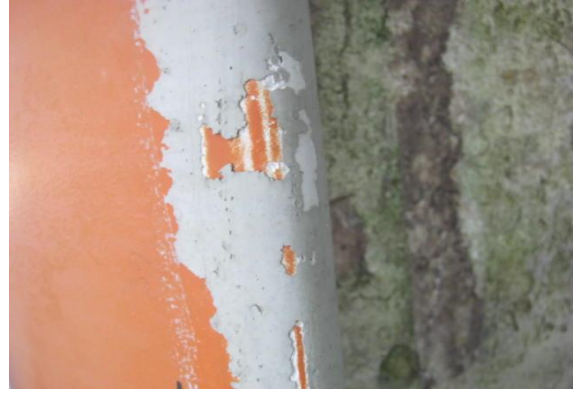
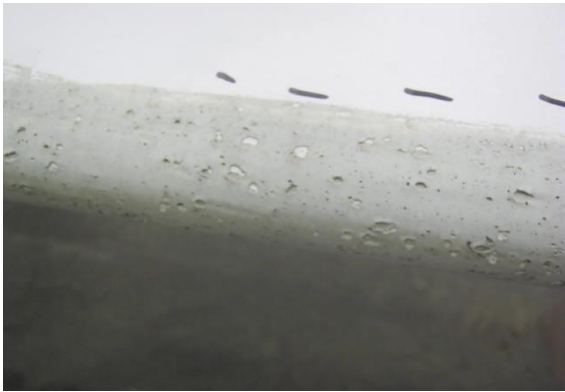
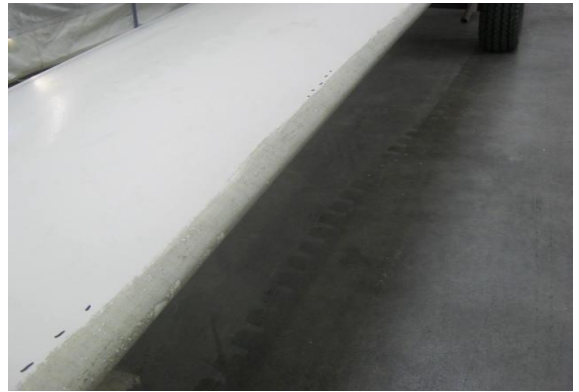
| Pos. | | Pressure side | | Suction side | | Pos. |
|---|---|---|---|---|--|---|
| 4 | R28-R37 VK Erosion, chipping & damaged E-foil<br>Rep: sanded, troweled, sanded & new paintable E-foil applied<br>Image: 31-50 | | 42,0 | | | |

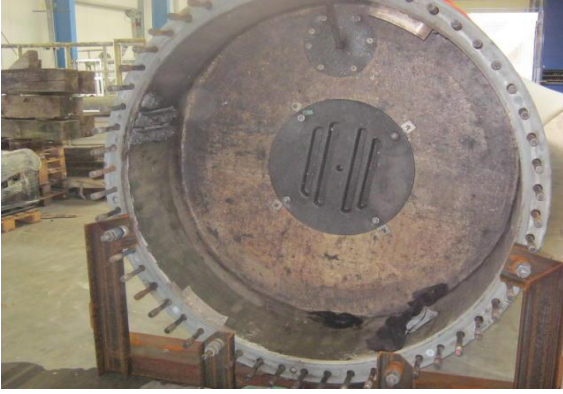
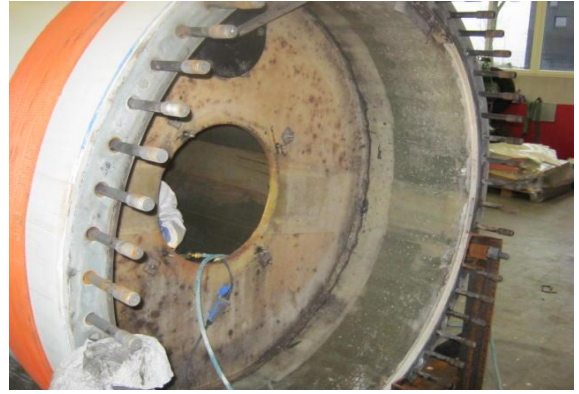
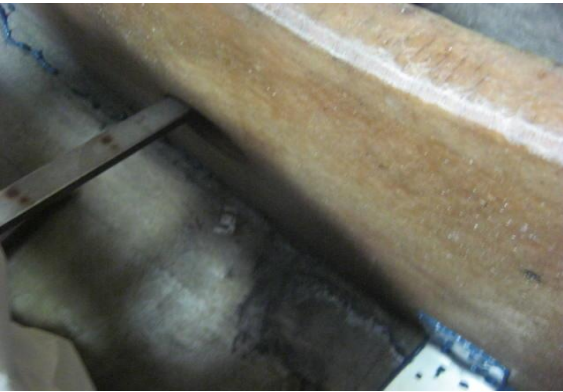
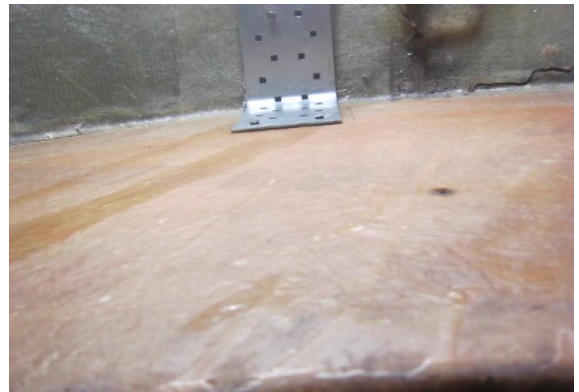
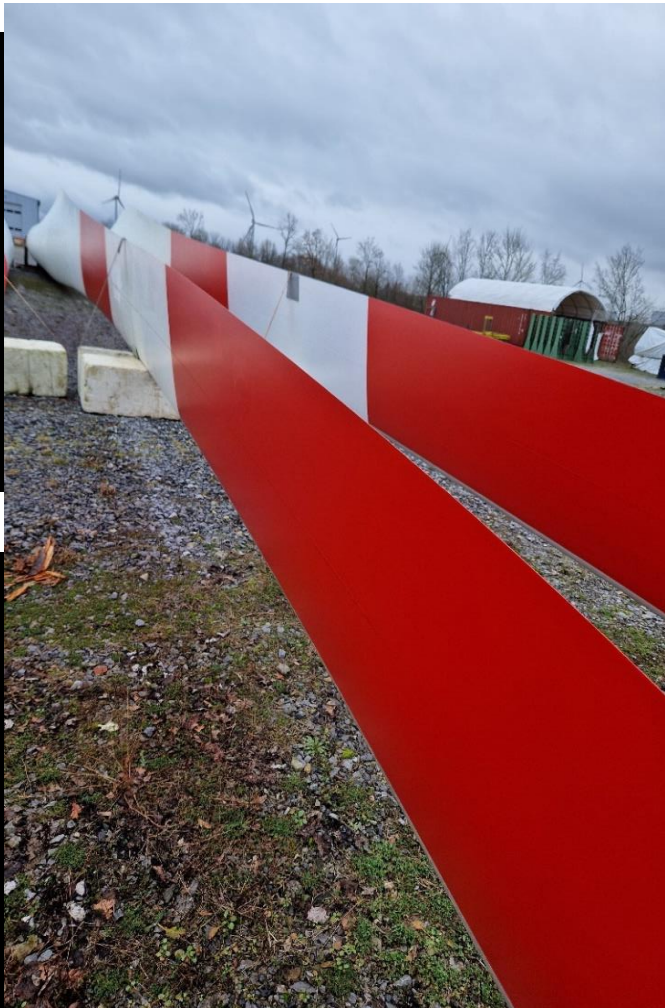
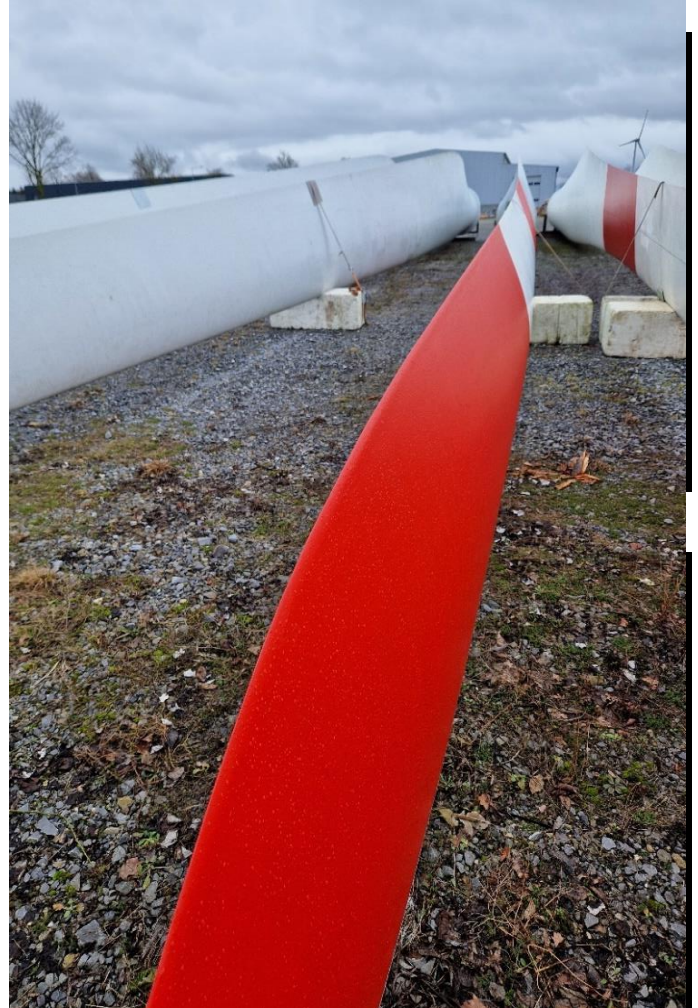
Sheet inside report:SS/HK/VK entry shot on approx. 3/4 of the circumference loose and broken. Areas cleaned & shot reinforced with angle. Image: 56-62

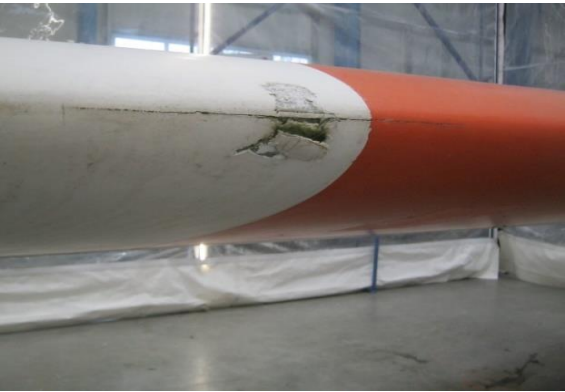
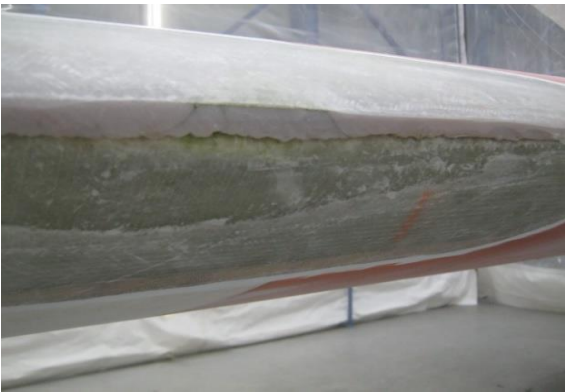
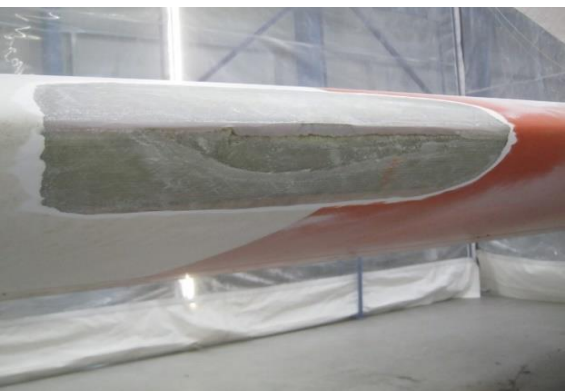
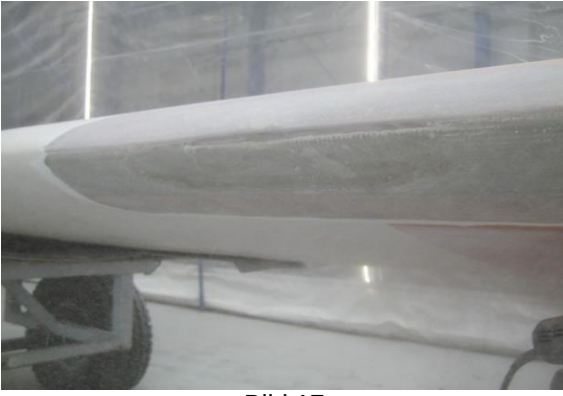
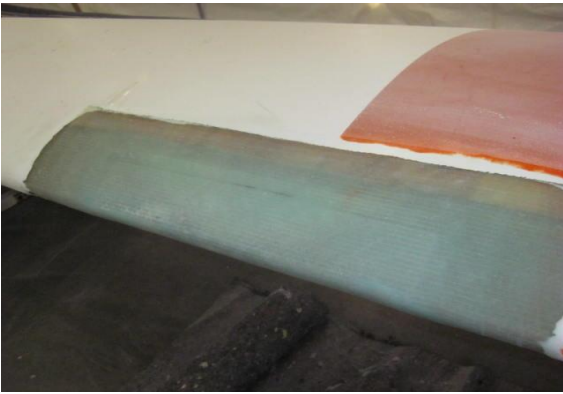
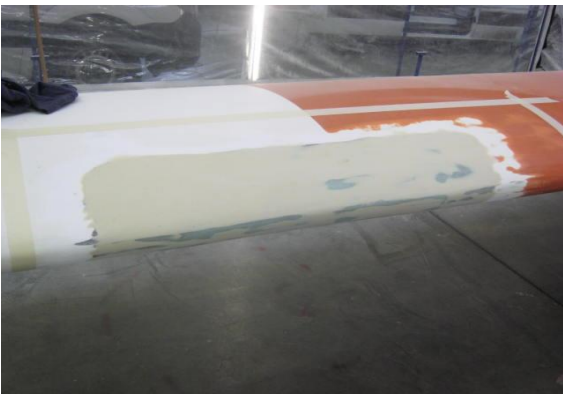
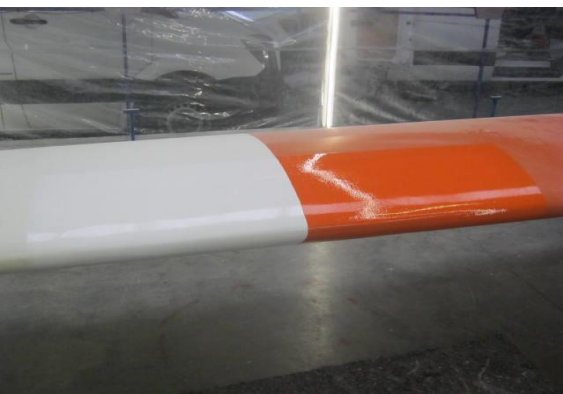
| Pos. | Pressure side | | Suction side | Pos. |
|---|---|---|---|---|
| 3 | R26-R27 VK longitudinal crack L= 40cm and chipping 10x5cm<br>Rep: sanded, 5-ply laminated filled,<br>sanded and varnished<br>Image: 11-23 | 25,0 | | |

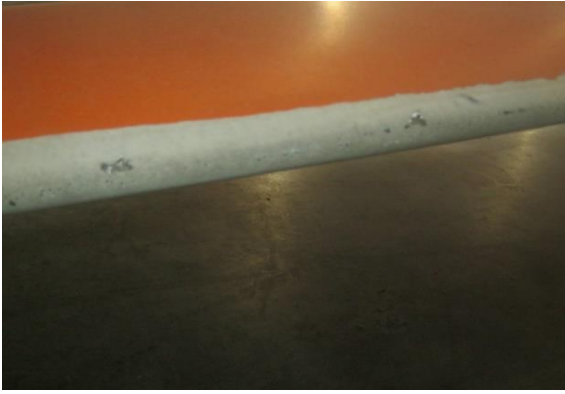
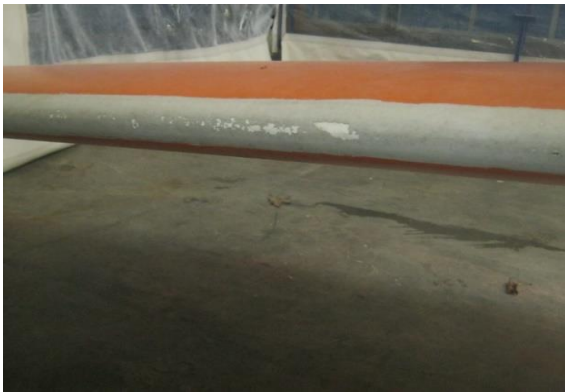
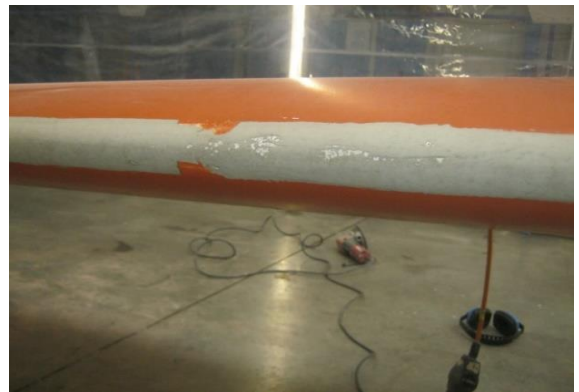
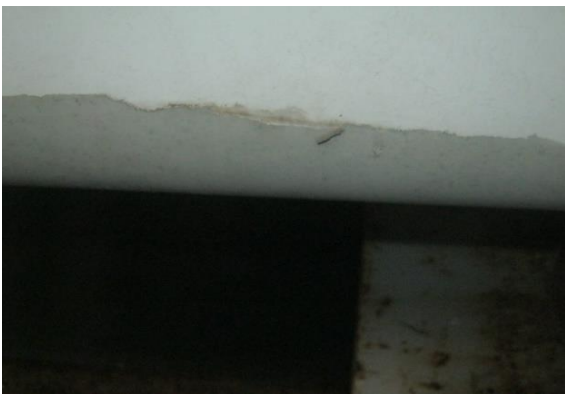
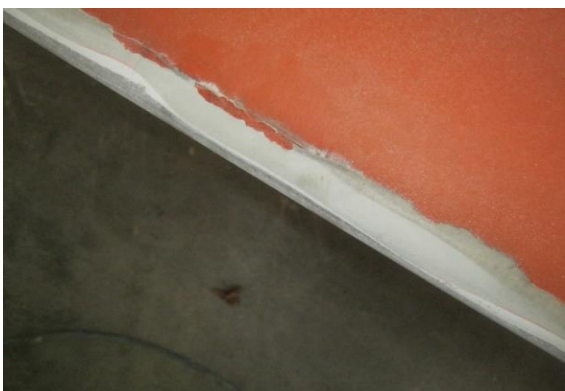
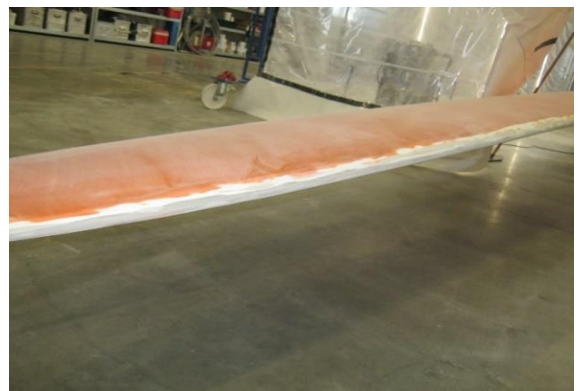
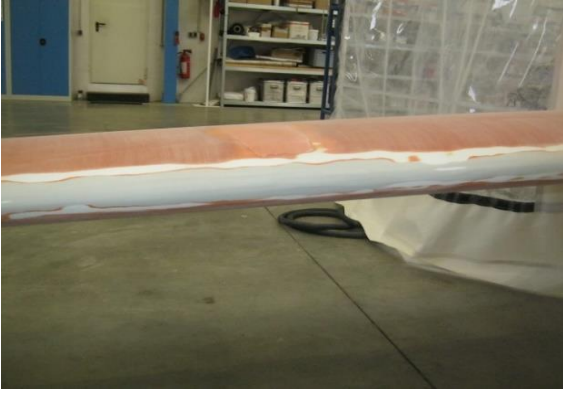
| Pos. | Pressure side | | Suction side | Pos. |
|---|---|---|---|---|
| 4 | R25-R37 VK Erosion, chipping & damaged E-foil<br>Rep: sanded, troweled, sanded & new paintable E-foil applied<br>Image: 24-40 | 33,0 | | |

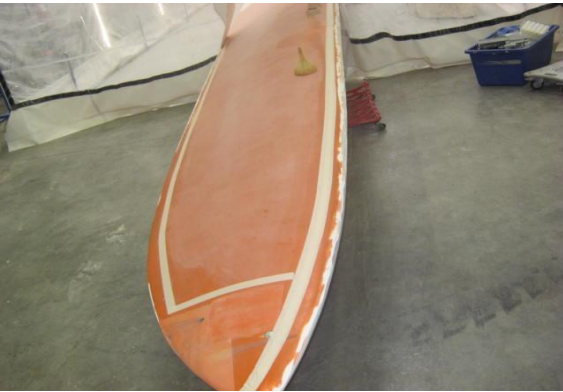
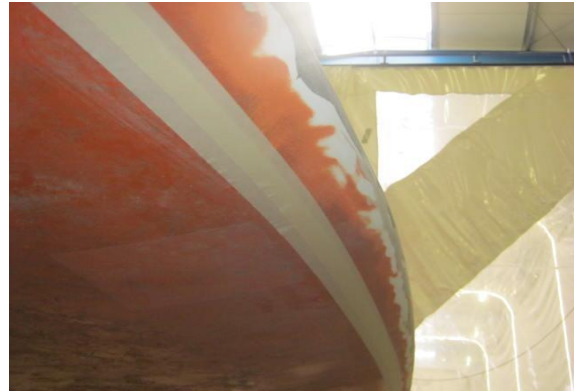
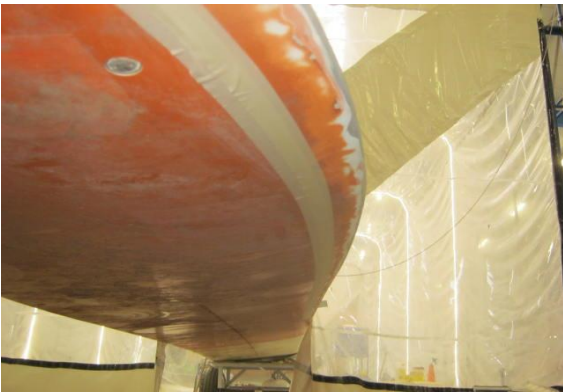
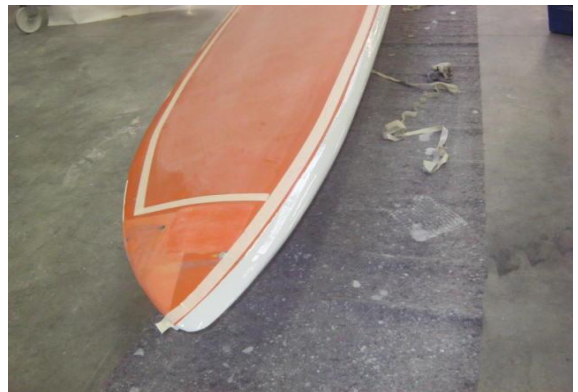
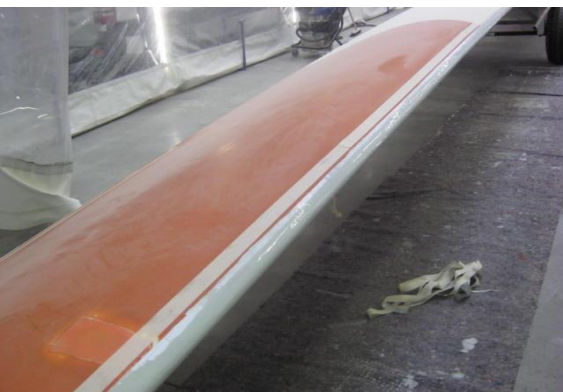
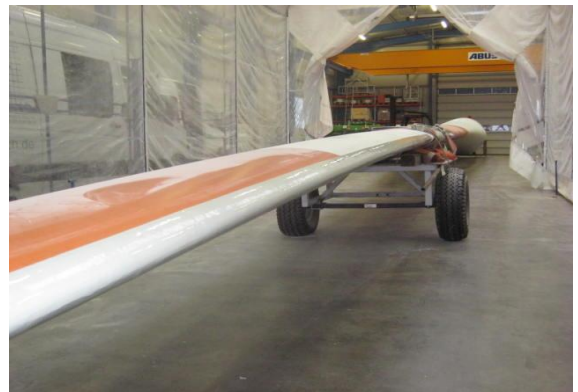
| Pos. | Pressure side | Suction side | Pos. |
|---|---|---|---|
| 6 | R33-R37 VK Paint Chipping & Erosion & Damaged E-Foil<br>Rep: sanded, troweled, sanded & new paintable E-foil applied<br>Image: 29-33 | 35,0 | |
