Gearbox Borescope Inspection

Ventos Metodicos Warehouse

WTG 1

Author	Daniel Fuentes Moncayo
Date	06/11/2025
Ref.	VMW_001_2025-11-06_GBB

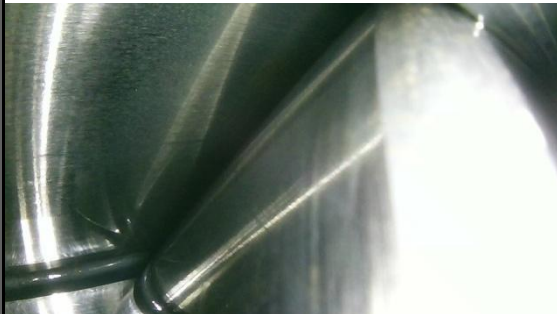
Obs: scoring	Obs: scoring

There is presence of scoring signs in the surfaces of the bearing.

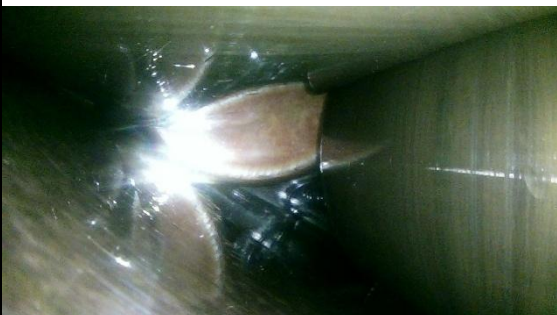
Obs: adhesion	Obs: adhesion

There is presence of adhesion signs in the surfaces of the bearing.
