# Gearbox Borescope Inspection

Ventos Metódicos Warehouse

WTG 2

Author	Daniel Fuentes Moncayo
Date	07/11/2025
Ref.	VMW_002_2025-11-07_GBB

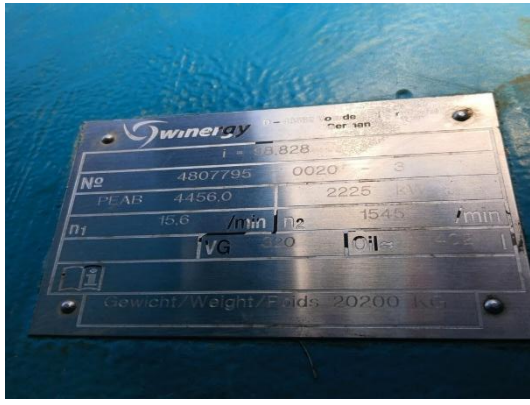
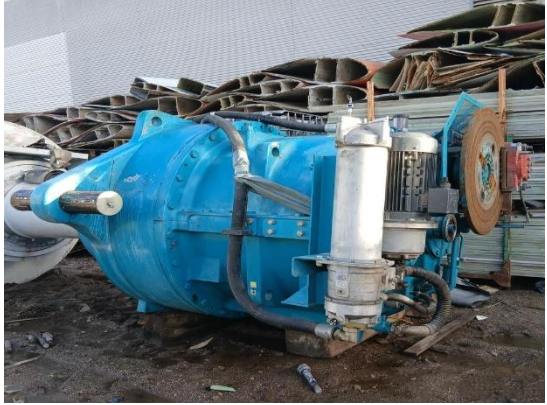
Obs: Nameplate		C	Obs: Main view

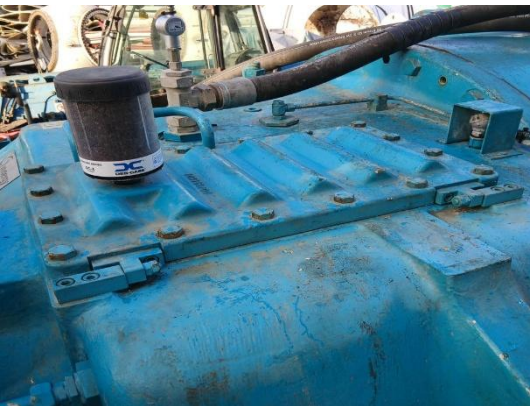
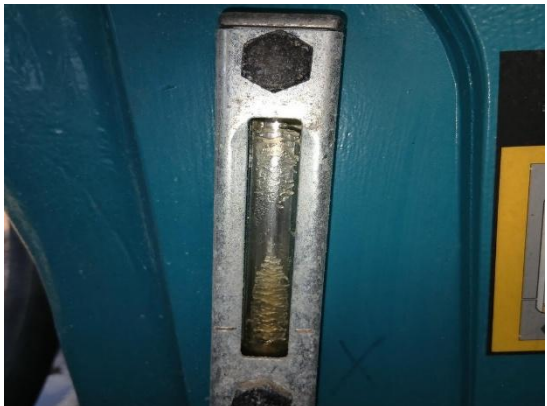
Obs: Filter		C	Obs: Oil level

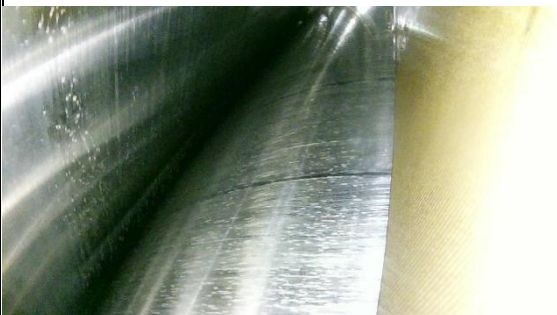
Obs: adhesion and scoring	Obs: adhesion and scoring

There is presence of adhesion and scoring signs in the surfaces of the bearing.

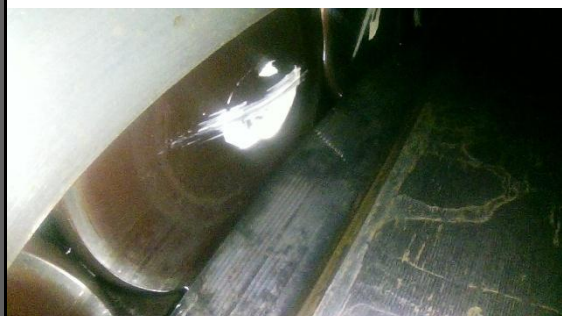
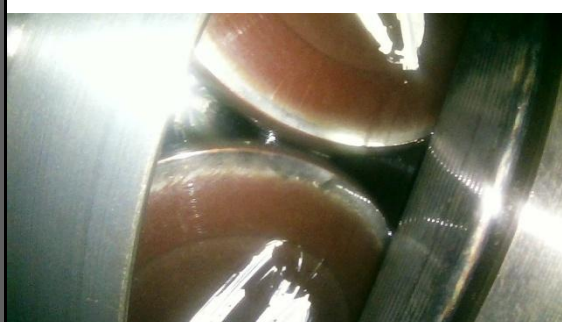
Obs: Outside view	Obs: Outside view

No access to the inside of the bearing.

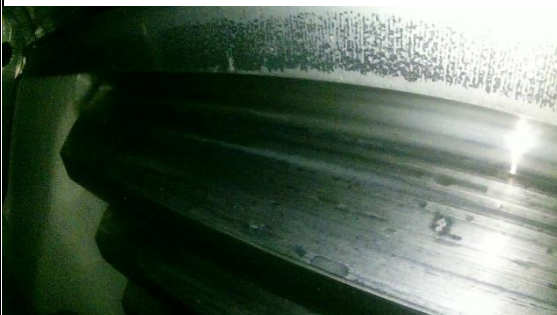
Obs: abrasion and micropitting	Obs: adhesion

There is presence of adhesion, abrasion and micropitting signs in the teeth of the gear.

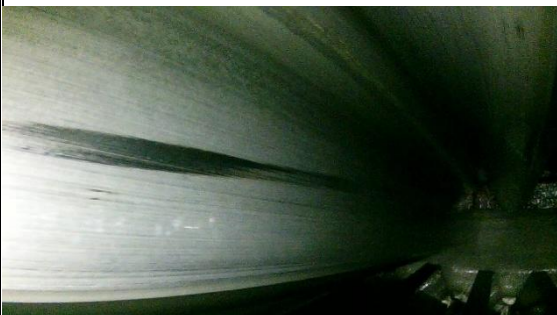
Obs: abrasion and standstill marks	Obs: abrasion and standstill marks

There is presence of standstill marks, abrasion and adhesion signs in the teeth of the gear.
